This Study documents our observations of existing conditions and identifies several options for redevelopment of the former American Furniture Plant #10; an operational pro forma of the City's preferred option is included.

Existing Conditions – Site

Existing Conditions – Building

Field Observations & Recommendations

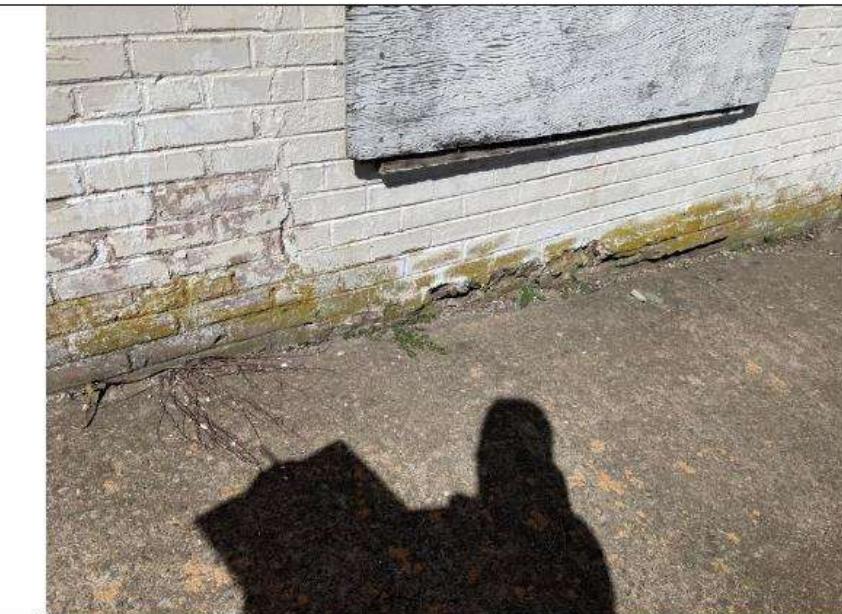
PHOTO 4 Location: Area 1 exterior
Description: Minor mortar wash along base of wall at sidewalk

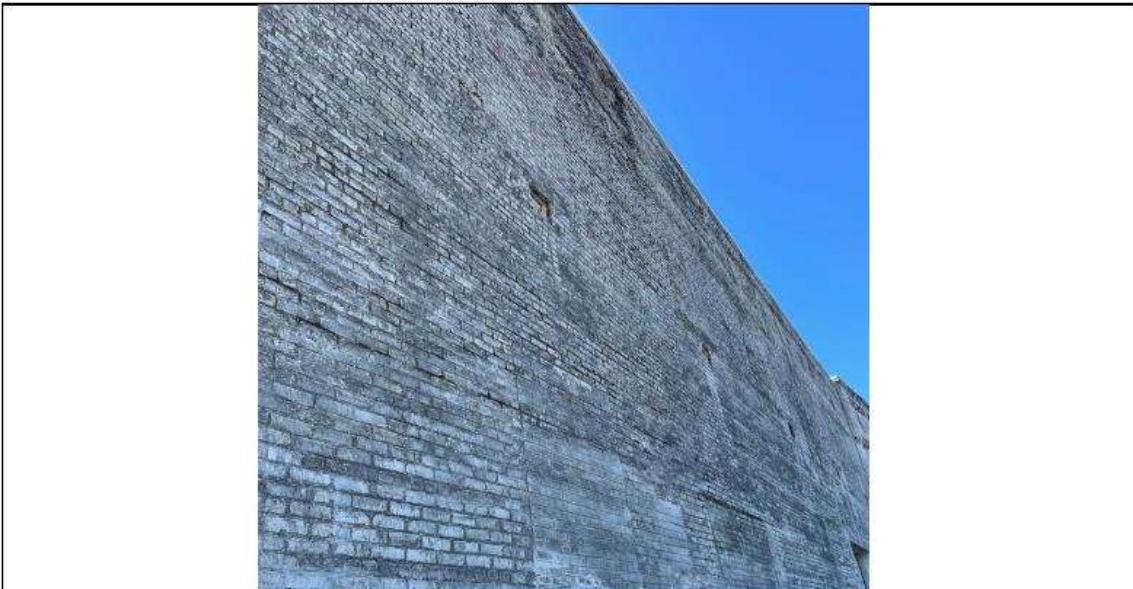
PHOTO 5	Location: Area 1 exterior
	Description: Cracking in masonry

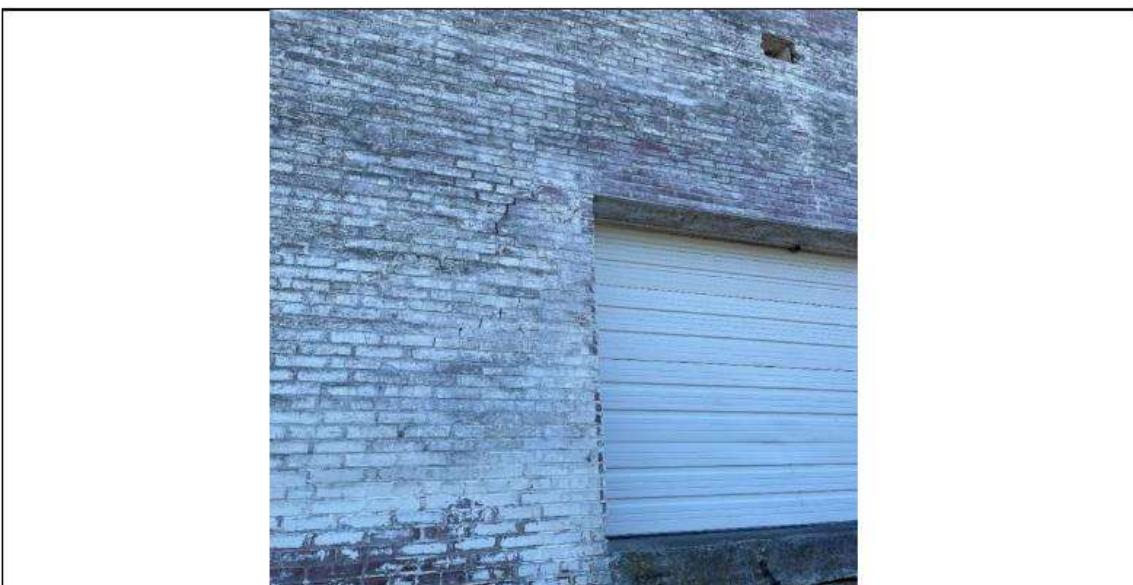
PHOTO 6	Location: Area 1 exterior
	Description: Cracking in masonry

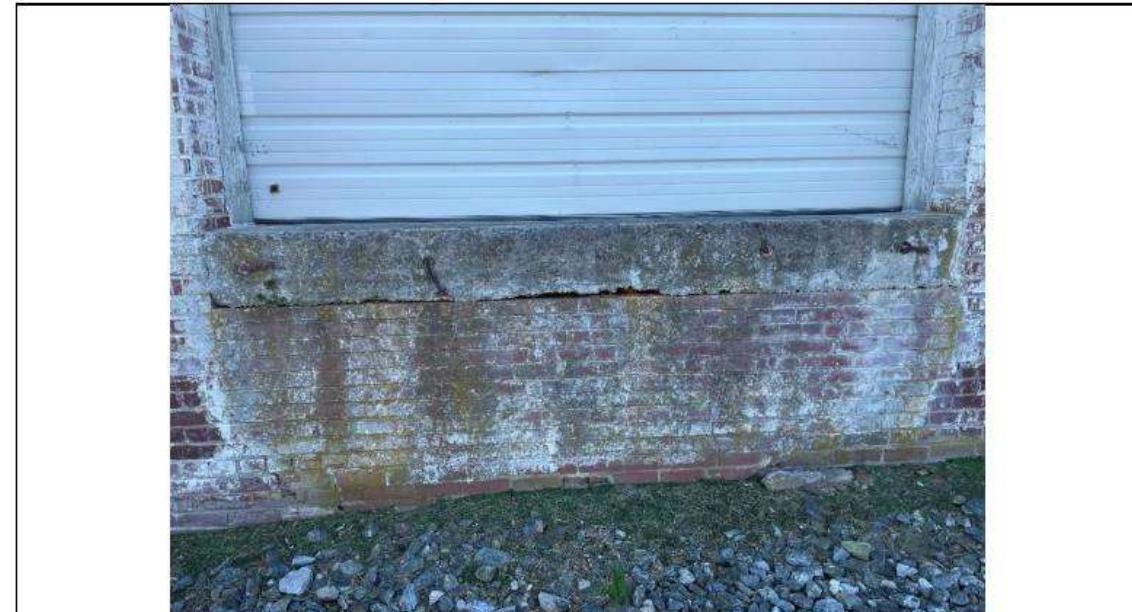
PHOTO 7	Location: Area 1 exterior
	Description: Cracking in masonry

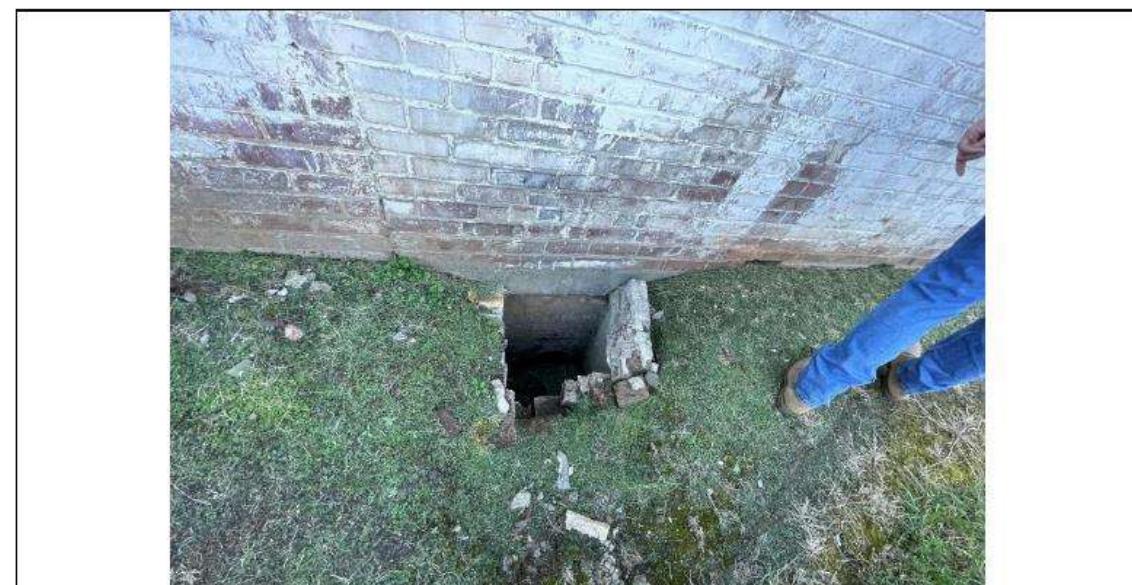
PHOTO 8	Location: Area 2 exterior
	Description: Hole to underdrain system. Questionable if working properly.

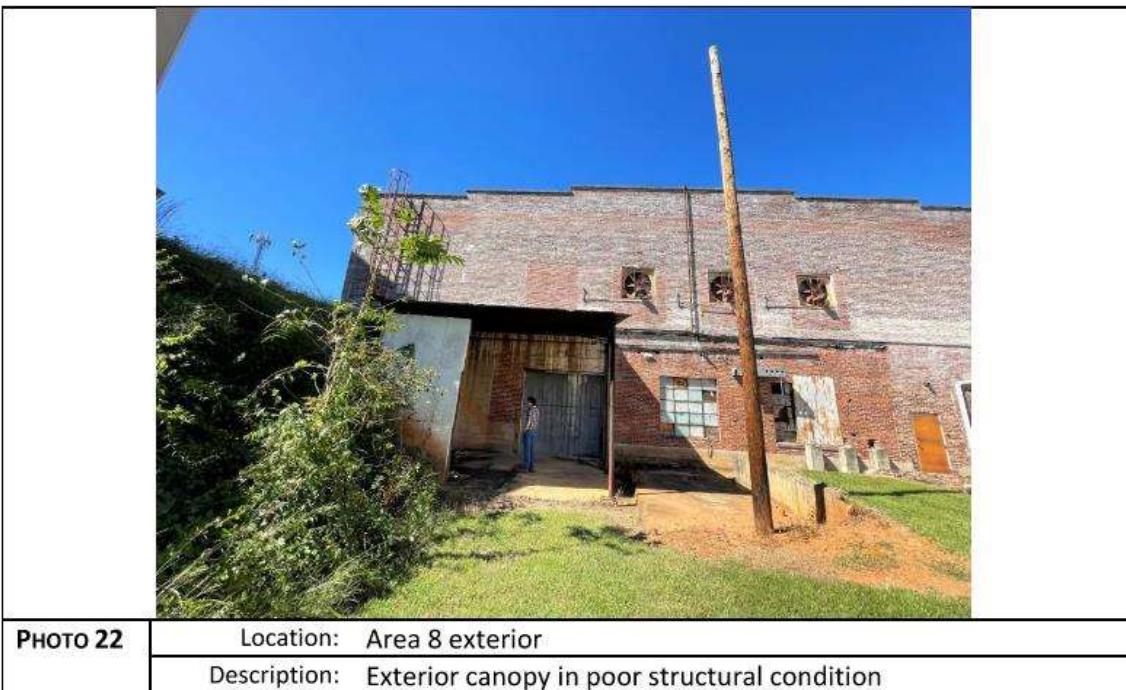
PHOTO 22 Location: Area 8 exterior
Description: Exterior canopy in poor structural condition

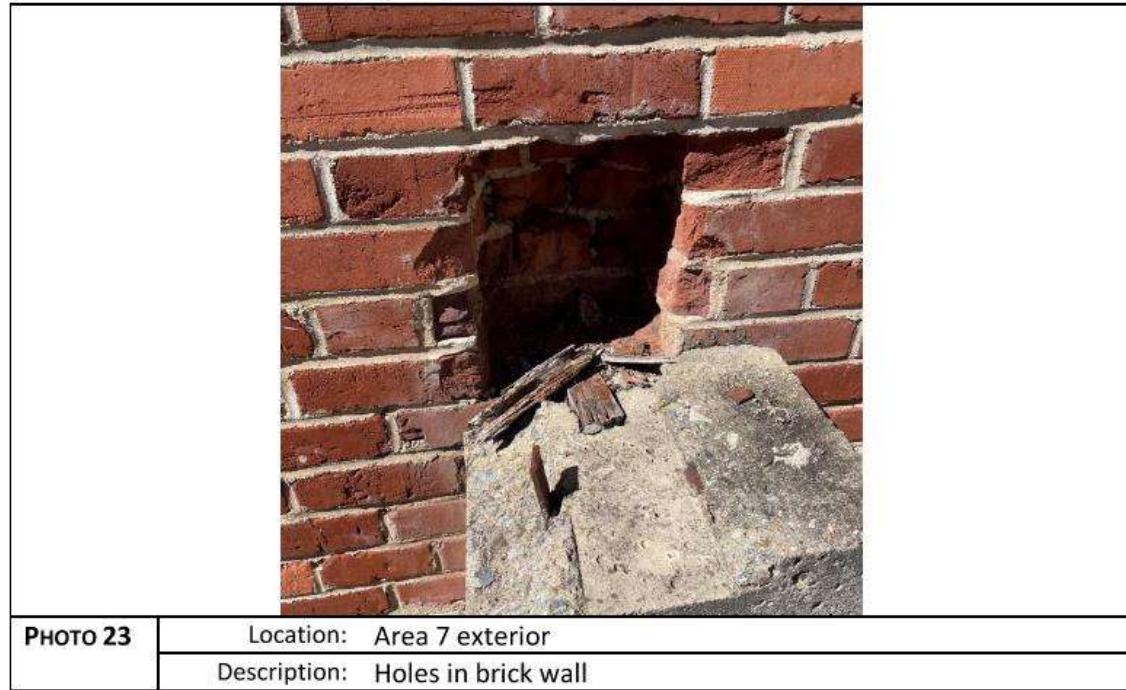
PHOTO 23 Location: Area 7 exterior
Description: Holes in brick wall

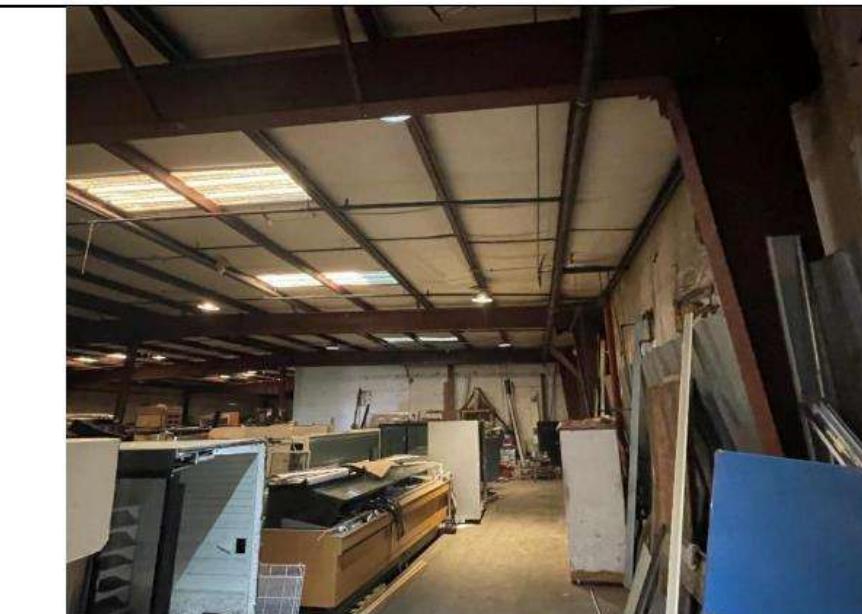
PHOTO 27 Location: Area 5 interior
Description: Typical condition

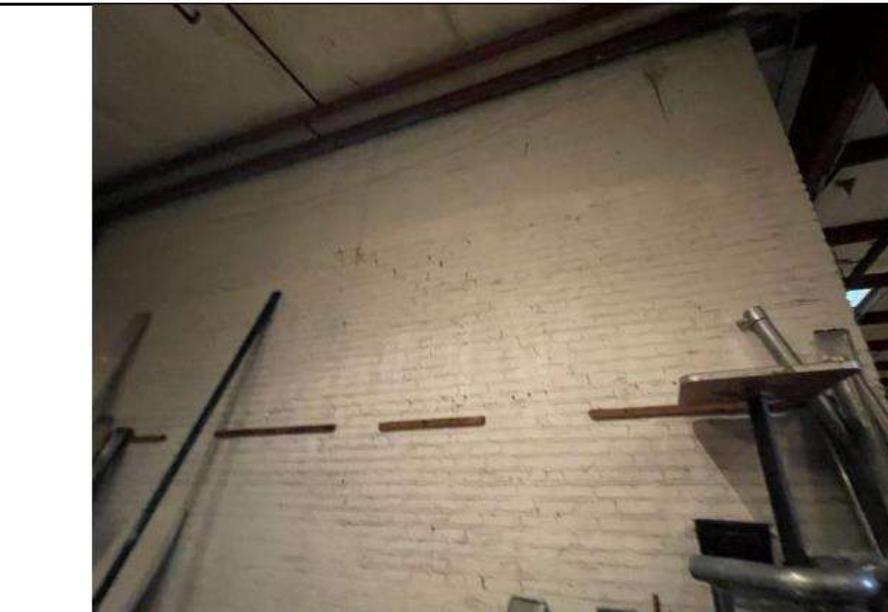
16. The masonry wall between Area 5 and 6 exhibits cracking in multiple locations. (Photos 30 and 31) The majority of the cracks are hairline. *We recommend repointing cracks and providing stiches for significant cracks.*

PHOTO 31 Location: Area 5 first floor
Description: Cracks along wall

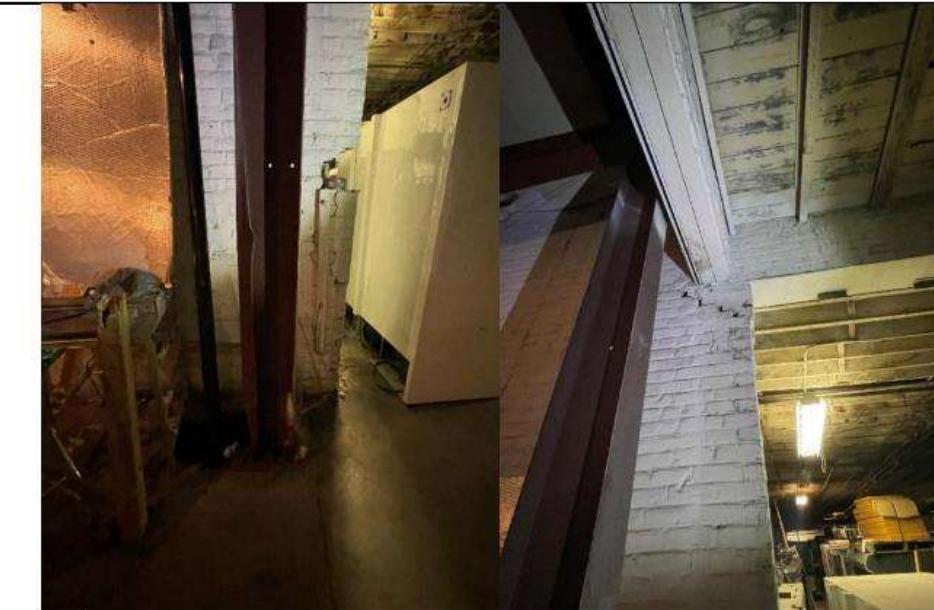
22. The bearing for a beam between Area 6 and 7 exhibits cracks. Gaps and cracks in the masonry pier can be observed as well. (Photo 32) *We recommend repairing the pier and cracks by relaying and repointing the masonry.*

PHOTO 32 Location: Area 1/8
Description: Cracks in wall at bearing and damage below from an impact

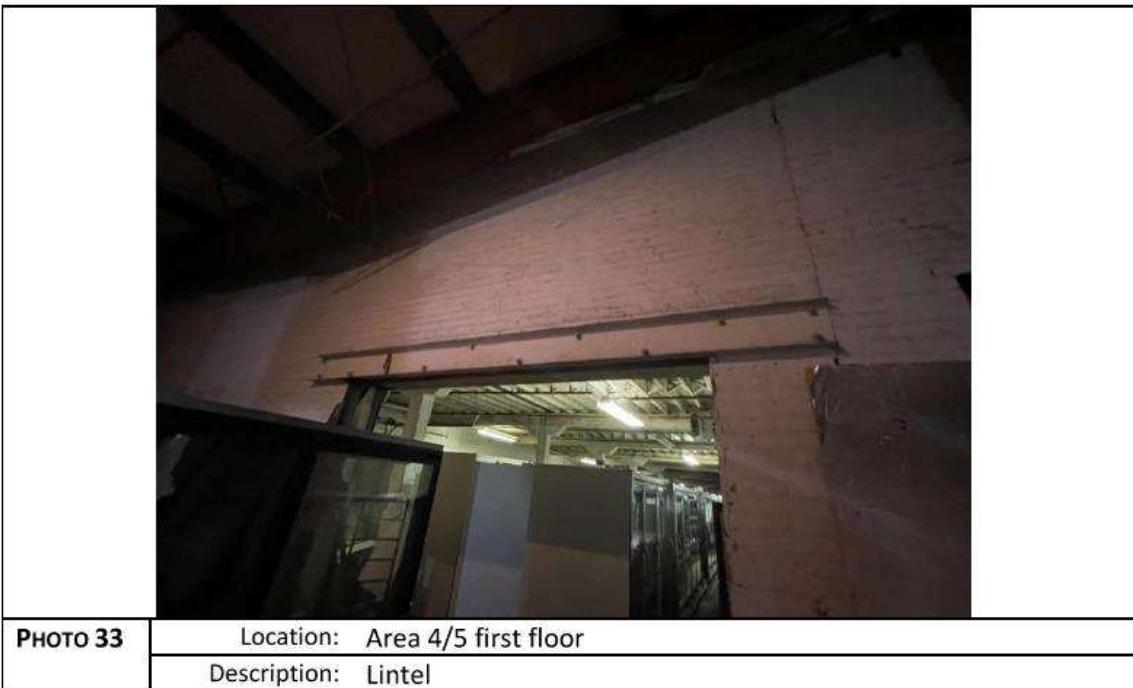
13. A significant portion of the masonry wall is missing on one side of the masonry opening between Area 5 and 4. There are jambs welded into place to support the lintel, but the jambs are loose and not properly fastened to the floor. (Photos 33 and 34)

PHOTO 33	Location: Area 4/5 first floor
	Description: Lintel

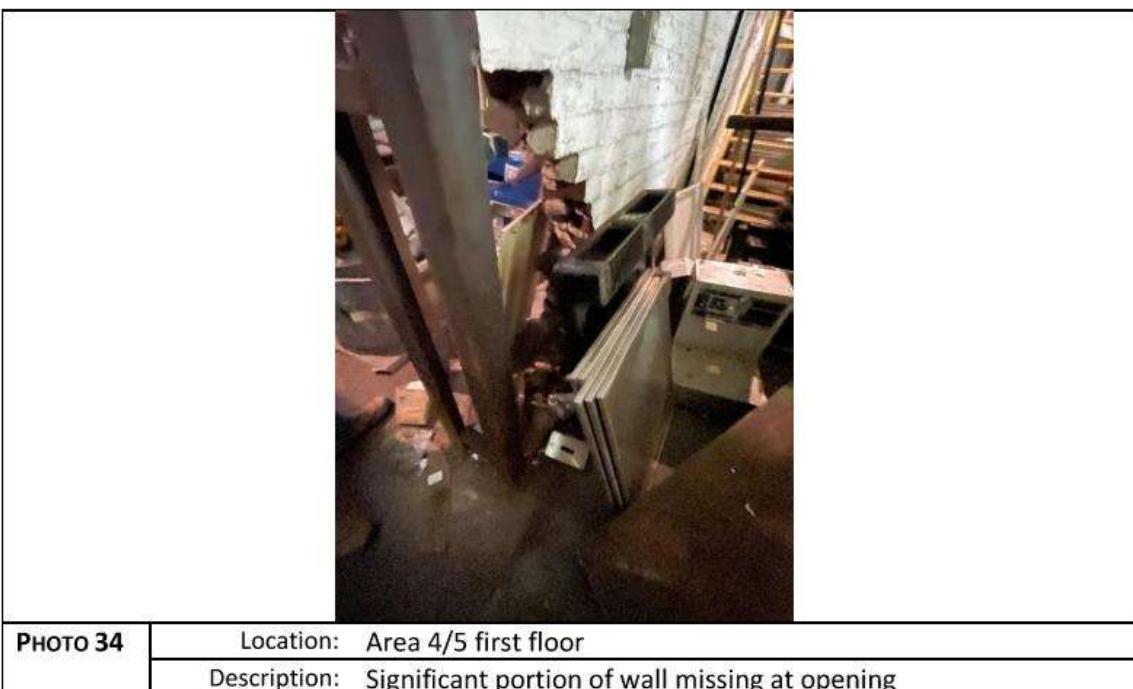
PHOTO 34	Location: Area 4/5 first floor
	Description: Significant portion of wall missing at opening

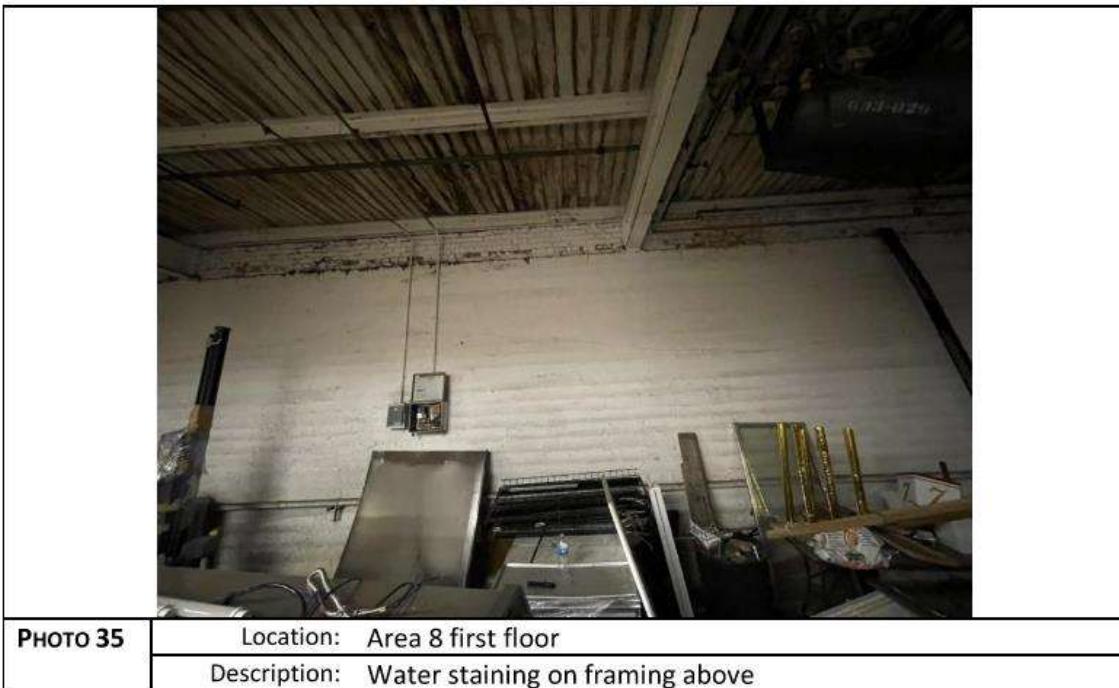
PHOTO 35	Location: Area 8 first floor
	Description: Water staining on framing above

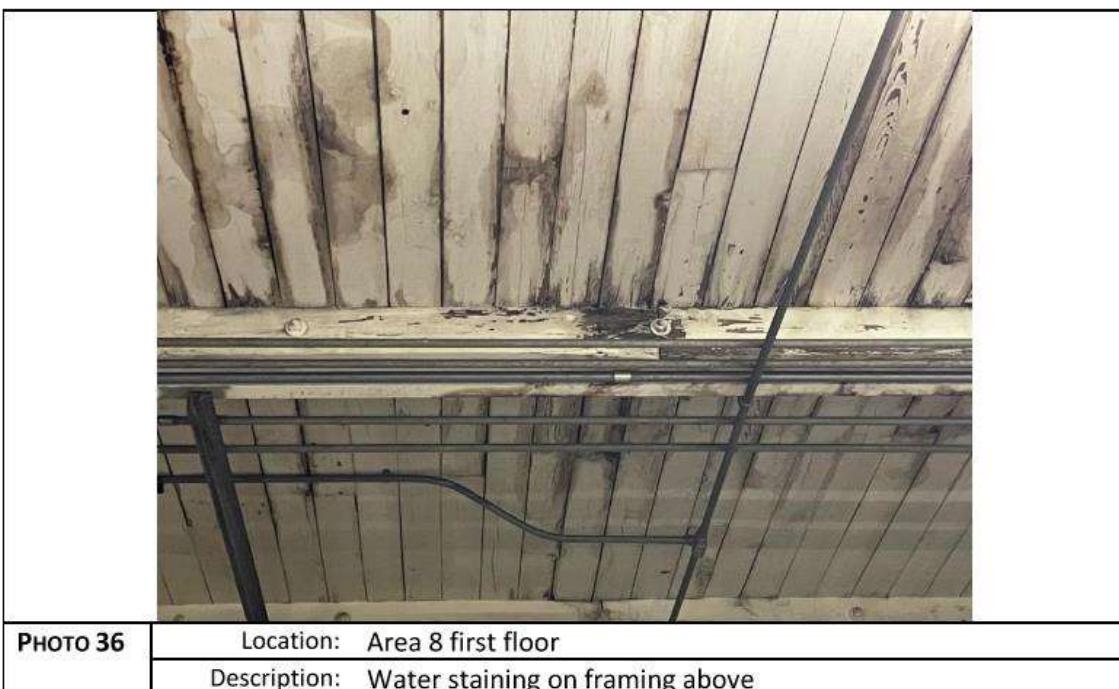
PHOTO 36	Location: Area 8 first floor
	Description: Water staining on framing above

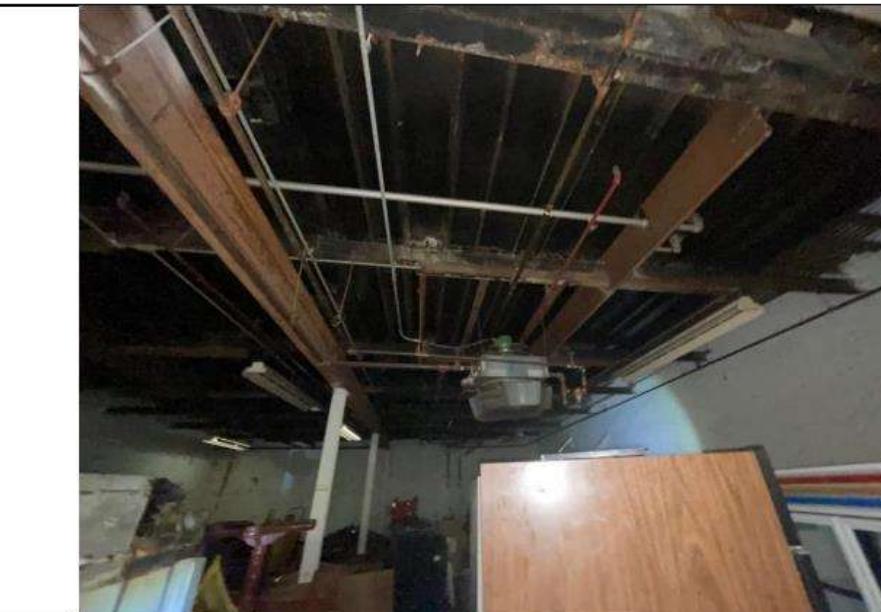
PHOTO 40	Location: Area 6 first floor
	Description: Overall view – metal "ceiling" in this location.

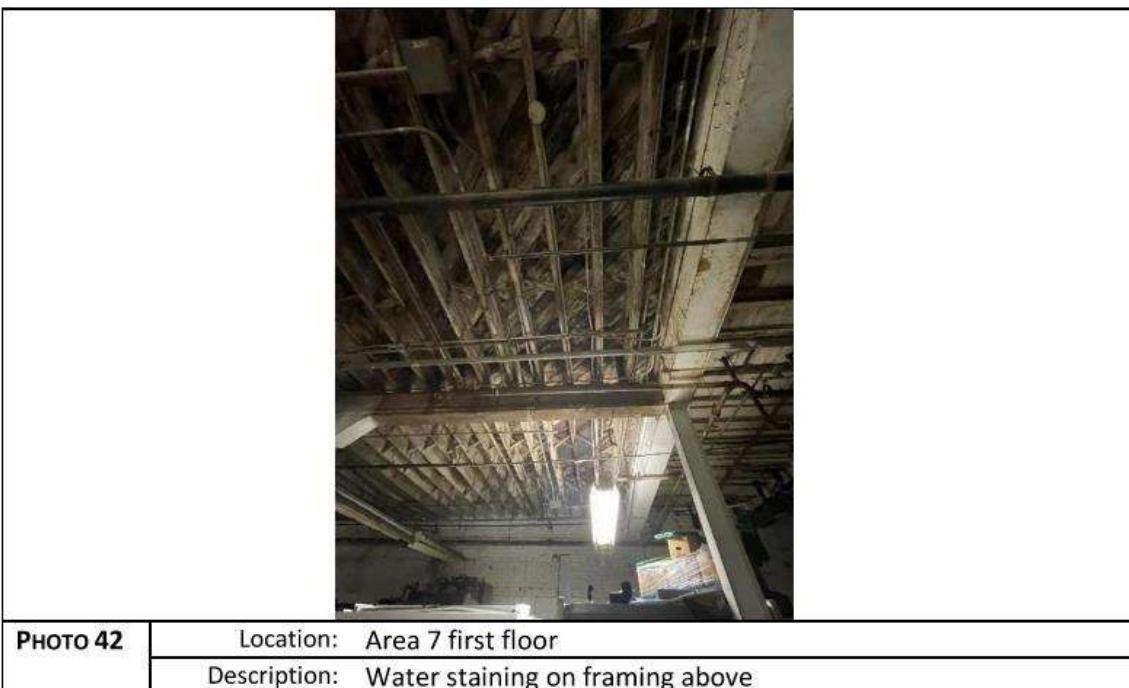
23. Underside of floor deck and framing in the western portion of this area exhibit significant water staining. (Photo 42) *A portion of this area feels “soft” to walk and may require new sub-floor.*

PHOTO 42 Location: Area 7 first floor
Description: Water staining on framing above

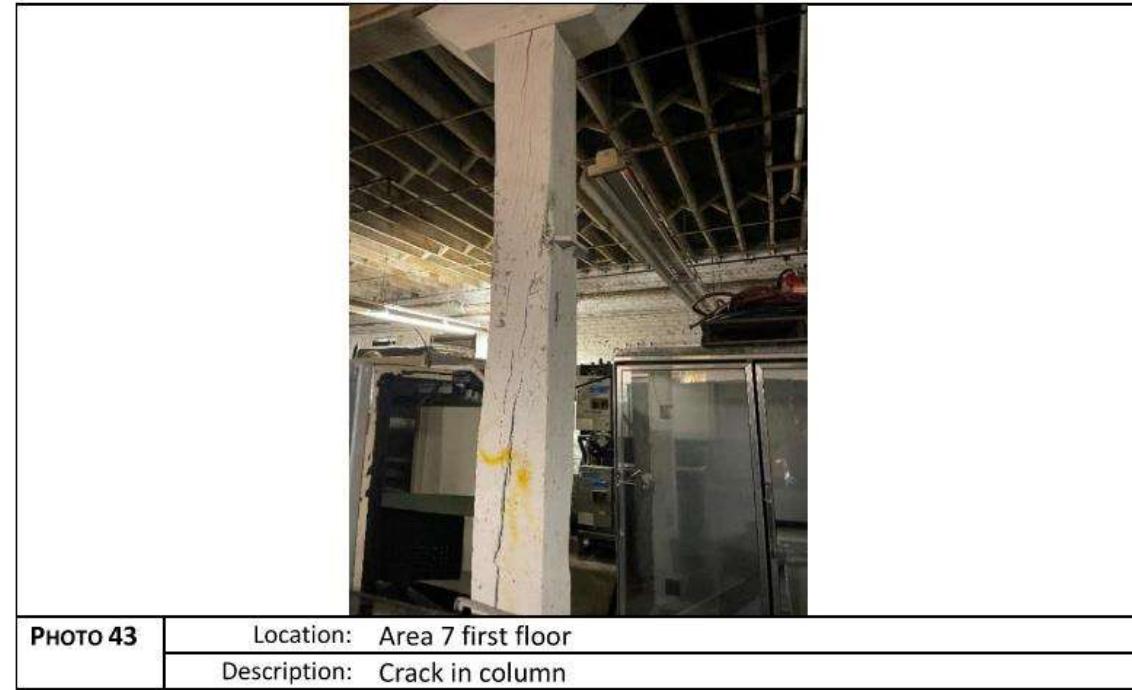
24. A few columns in this area exhibit cracks and checks. (Photo 43) none of the columns appeared over stressed or deteriorated and may be stable. *Once the area is removed of all items another visual assessment of the columns should be performed to identify areas of concern not readily visible during this assessment.*

PHOTO 43 Location: Area 7 first floor
Description: Crack in column

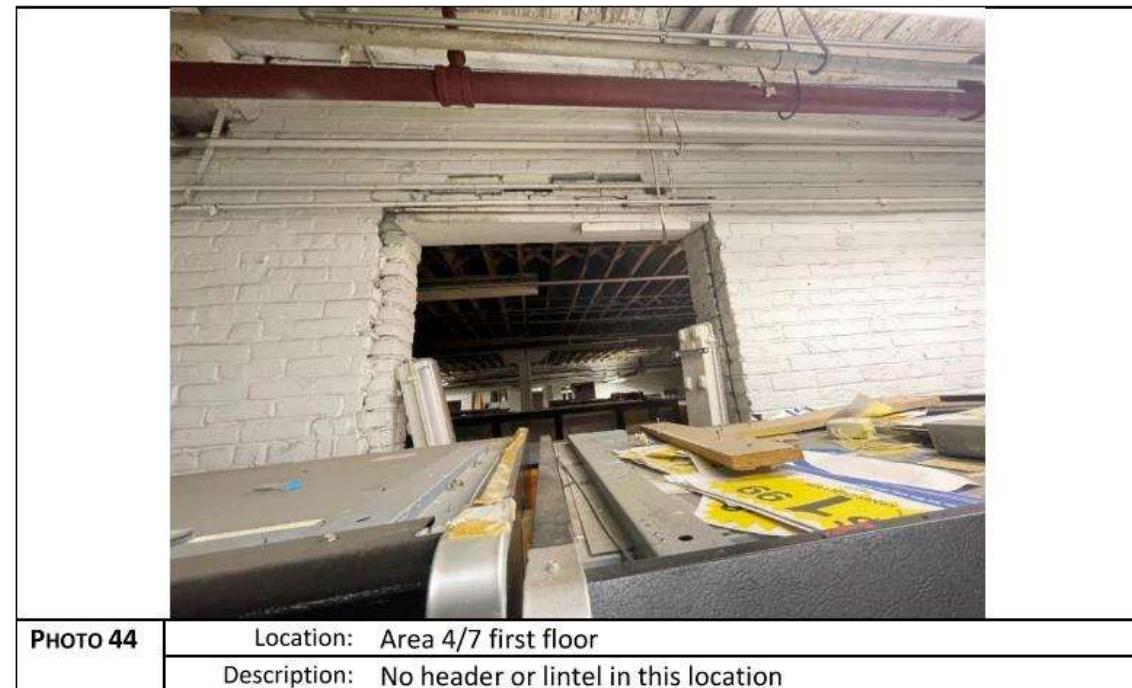
21. No headers or lintels were noted at an opening between Area 4 and 7. Some of the bricks around this location are loose. There are multiple holes along the wall from previous conduit and ductwork. (Photo 44) *We recommend infilling the holes not needed and installing lintels in the openings that need to remain.*

PHOTO 44 Location: Area 4/7 first floor
Description: No header or lintel in this location

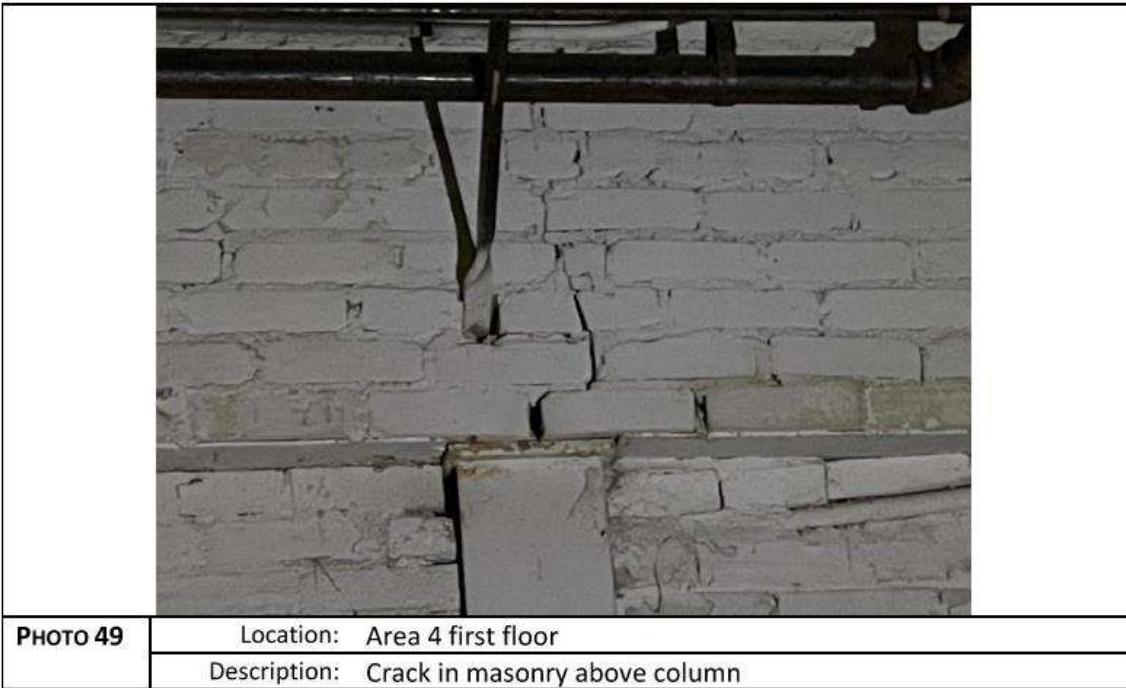
20. A beam in the middle of this area (location on note log) is twisted, has a hole, and exhibits staining from water damage. (Photo 50) *We recommend a closer, hands-on assessment of this area to determine if stabilization is required.*

PHOTO 50	Location: Area 7 first floor
	Description: Staining on beam

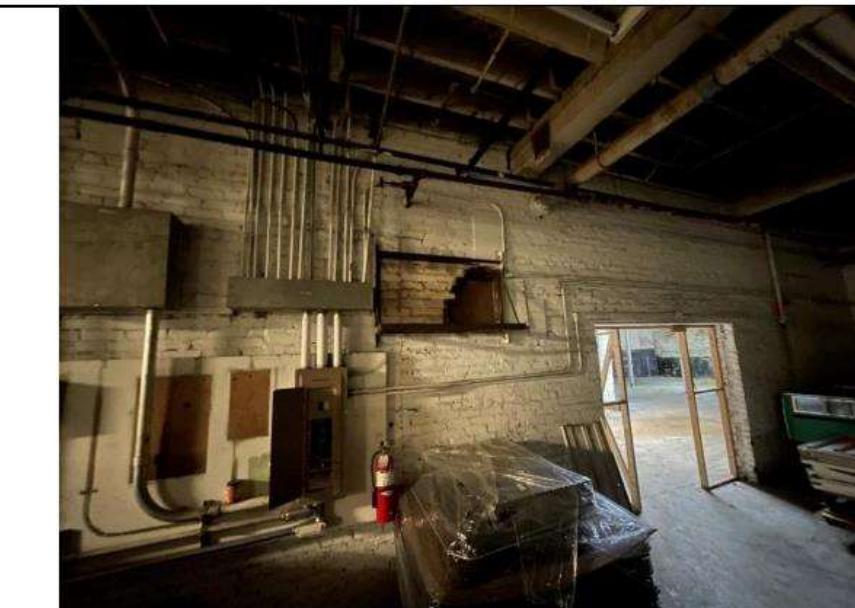
6. There is an opening near the south end of the dividing wall between Area 2 and 1 that does not have a header or lintel. (Photo 55) *This opening is partially infilled and if not required for final alteration plans should be completely infilled or reconstructed with a properly sized lintel.*
7. There are multiple wood columns in the area exhibiting damage, including cracking, bowing, and rotation. These columns also have large notches. (Photos 56 and 57) *Notches should be filled with blocking to provide full bearing area of columns.*
8. One column in the southern portion of the area was replaced with (5) 2x10 wood studs. (Photo 58)
9. There is a portion of framing near the middle of the area that was removed and in-filled with new framing. (Photo 52)

PHOTO 55	Location: Area 2 first floor
	Description: No header or lintel in this location

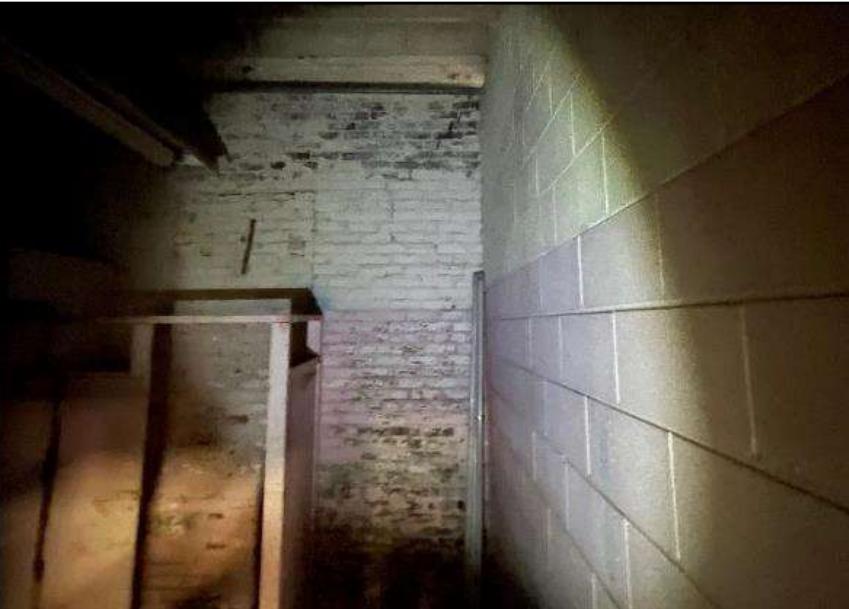
PHOTO 54	Location: Area 2 first floor
	Description: Significant damage to masonry at opening

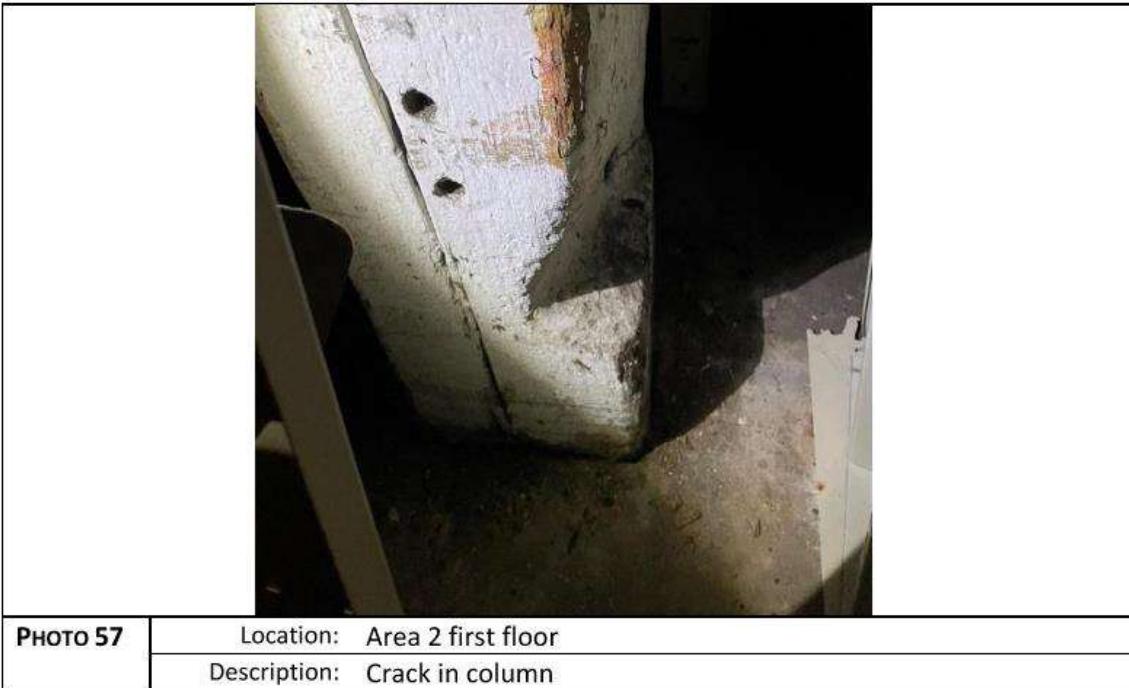
PHOTO 57	Location: Area 2 first floor
	Description: Crack in column

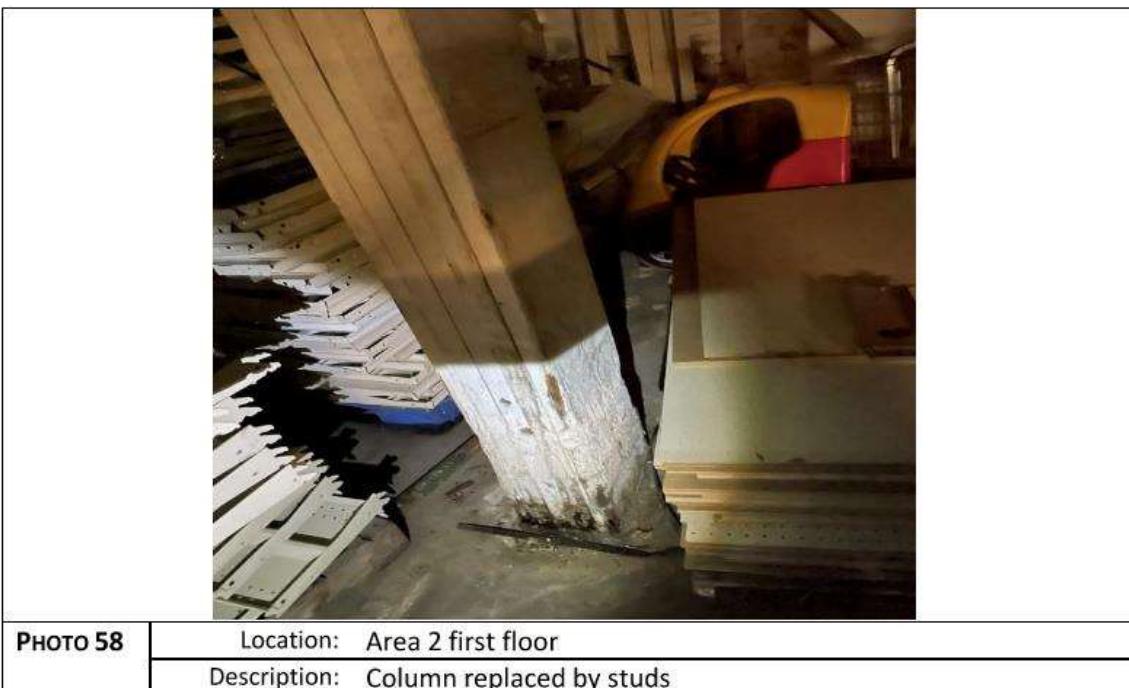
PHOTO 58	Location: Area 2 first floor
	Description: Column replaced by studs

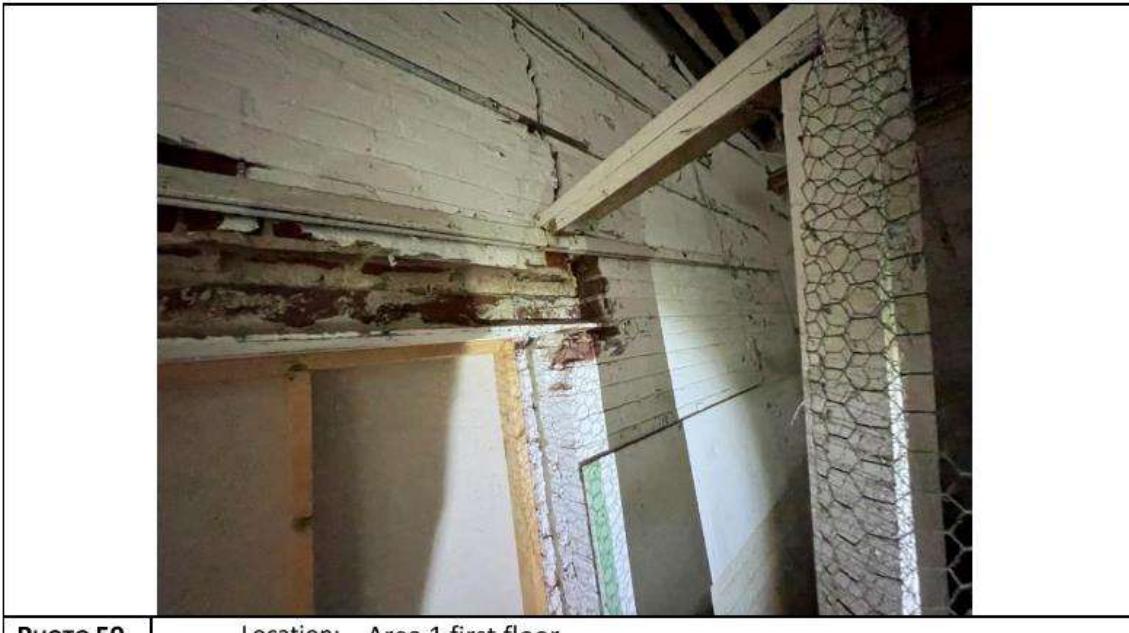
PHOTO 59	Location: Area 1 first floor
	Description: Significant damage to masonry at opening

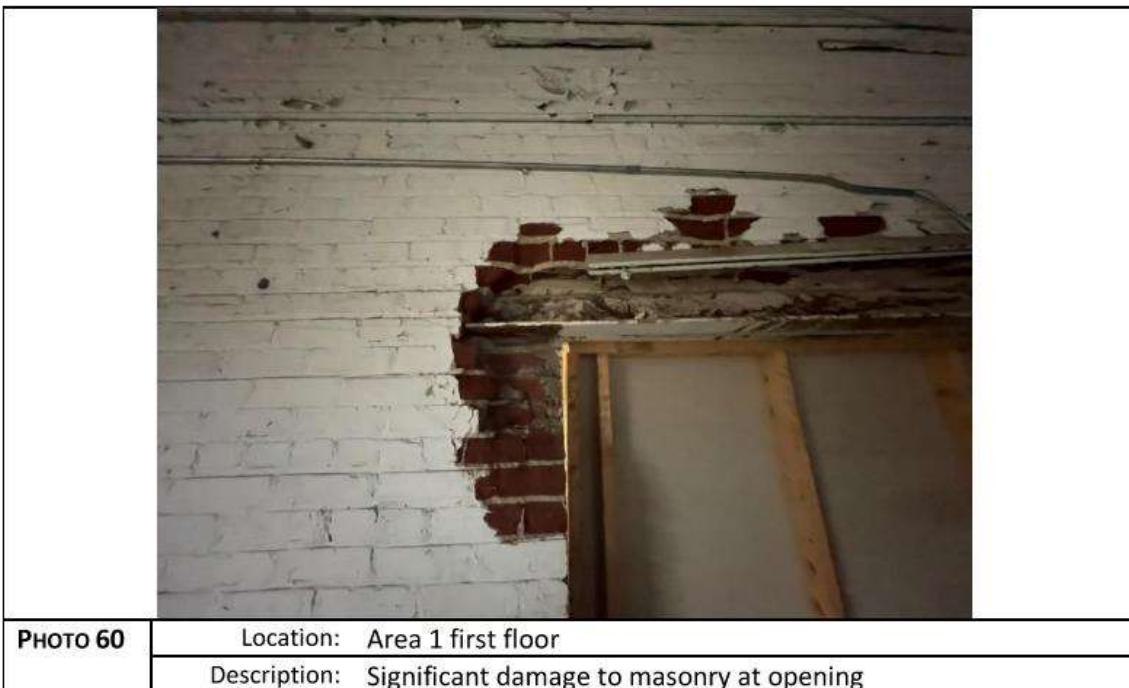
PHOTO 60	Location: Area 1 first floor
	Description: Significant damage to masonry at opening

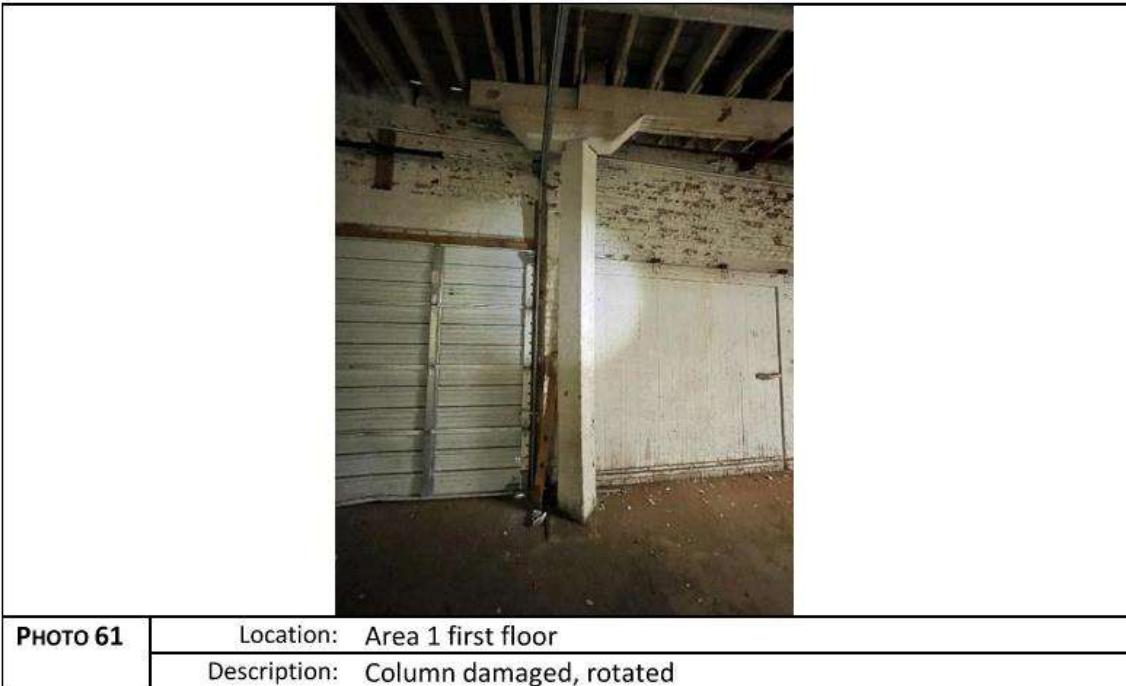
1. The east wall (Lester Street) exhibits areas of soft and spalling brick. See Photo 62.
2. Multiple wood and steel columns exhibit damage, including cracking, bowing, and rotation resulting from impact. (Photos 61 and 63) *It is recommended that these columns be stabilized, relocated and repaired as needed.*

PHOTO 61	Location: Area 1 first floor
	Description: Column damaged, rotated

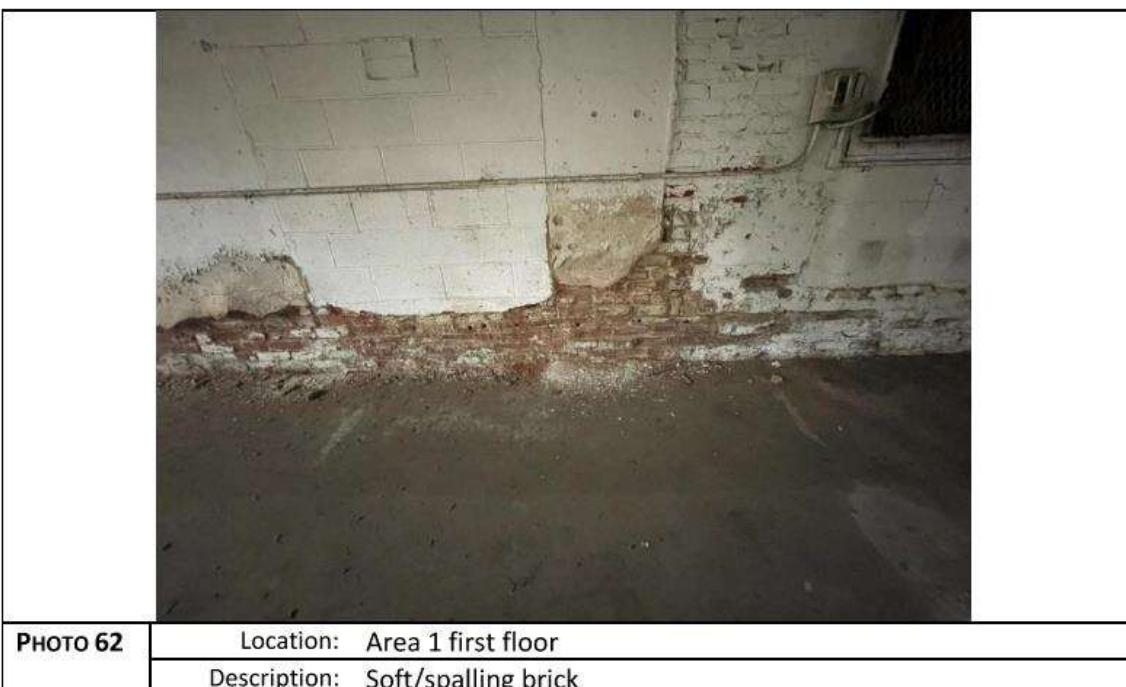
PHOTO 62	Location: Area 1 first floor
	Description: Soft/spalling brick

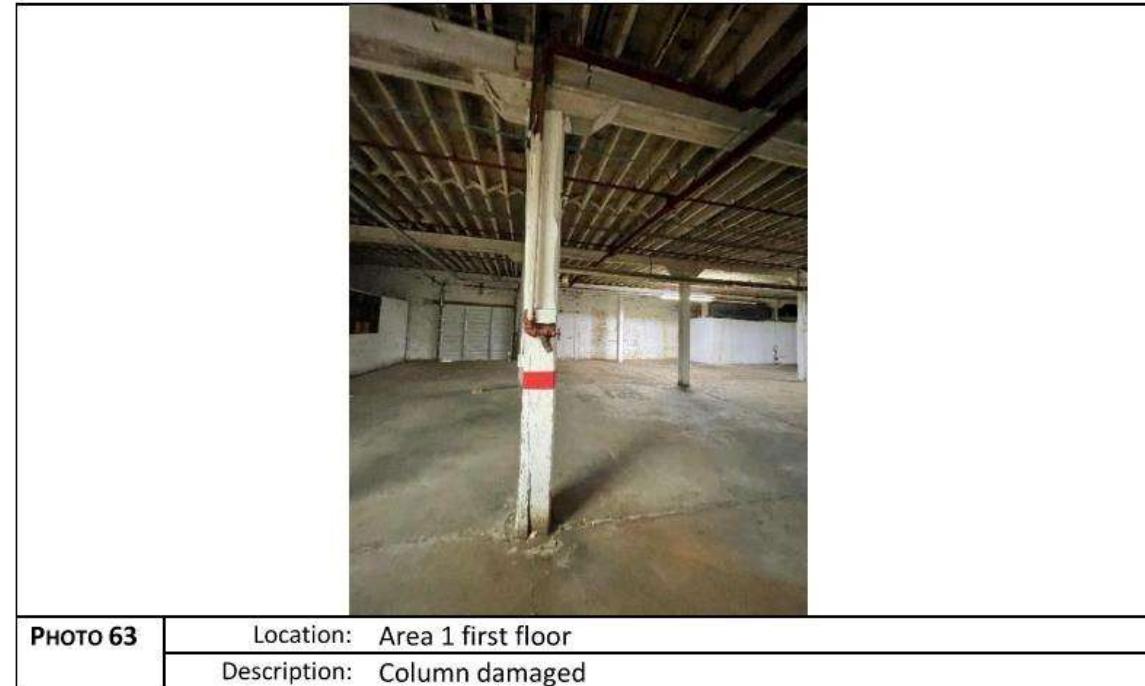
PHOTO 63	Location: Area 1 first floor
	Description: Column damaged

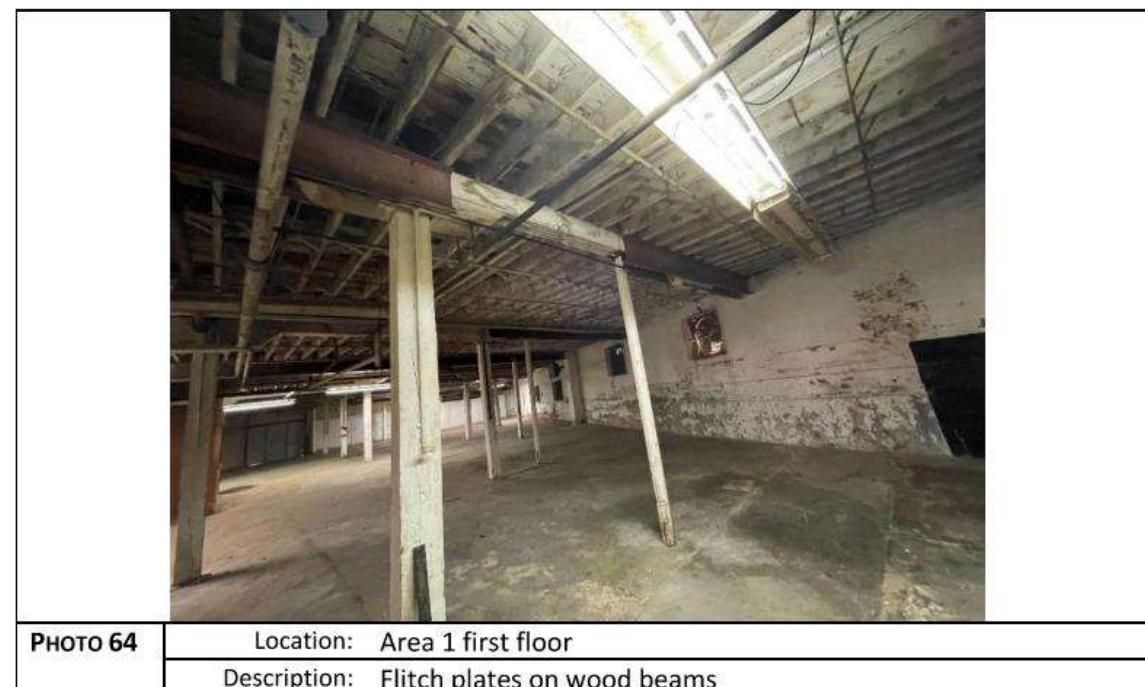
3. Flitch plates were noted at the ends of the girders in two locations, likely placed for the removal of columns (Photo 64). *It is unclear if the capacity of the flitch plates and modifications were properly sized and therefore it is recommended that the capacity be checked during design of alterations.*

PHOTO 64	Location: Area 1 first floor
	Description: Flitch plates on wood beams

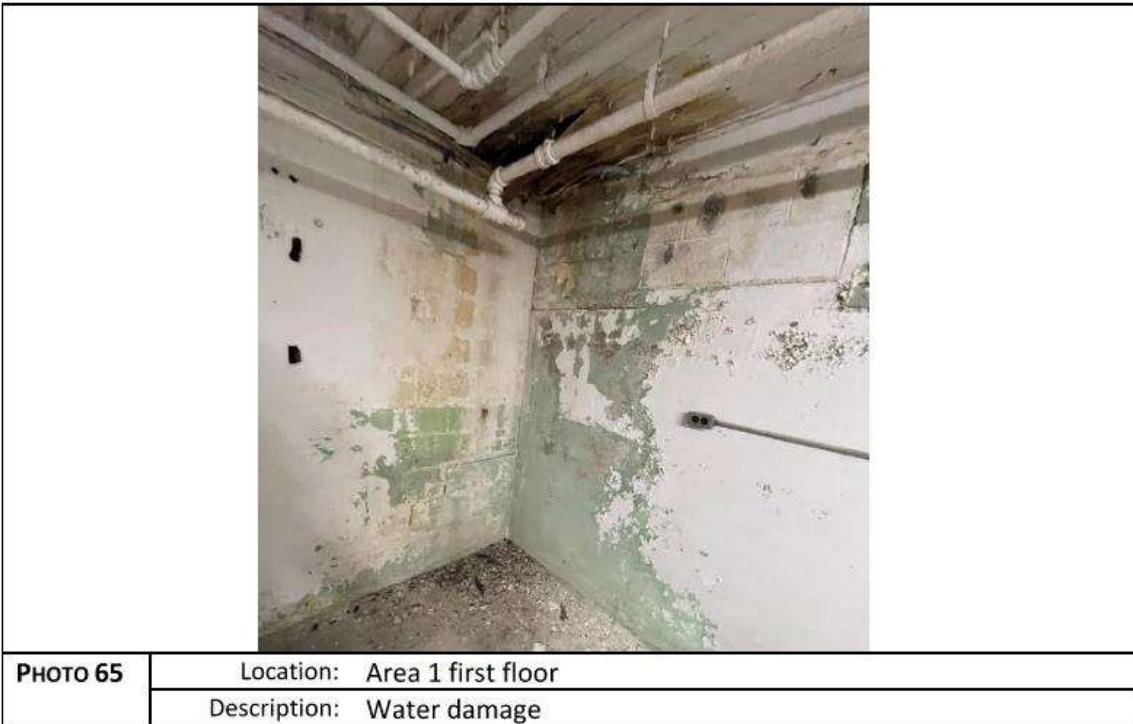
5. Water damage was noted on the underside of the 2nd floor framing in the southeast corner of the half height room. (Photo 65). *A closer investigation may require some of the upper-floor floor-boards to be replaced.*

PHOTO 65	Location: Area 1 first floor
	Description: Water damage
