This Study documents our observations of existing conditions and identifies several options for redevelopment of the former American Furniture Plant #10; an operational pro forma of the City's preferred option is included.

Existing Conditions – Site

Existing Conditions – Building

Field Observations & Recommendations

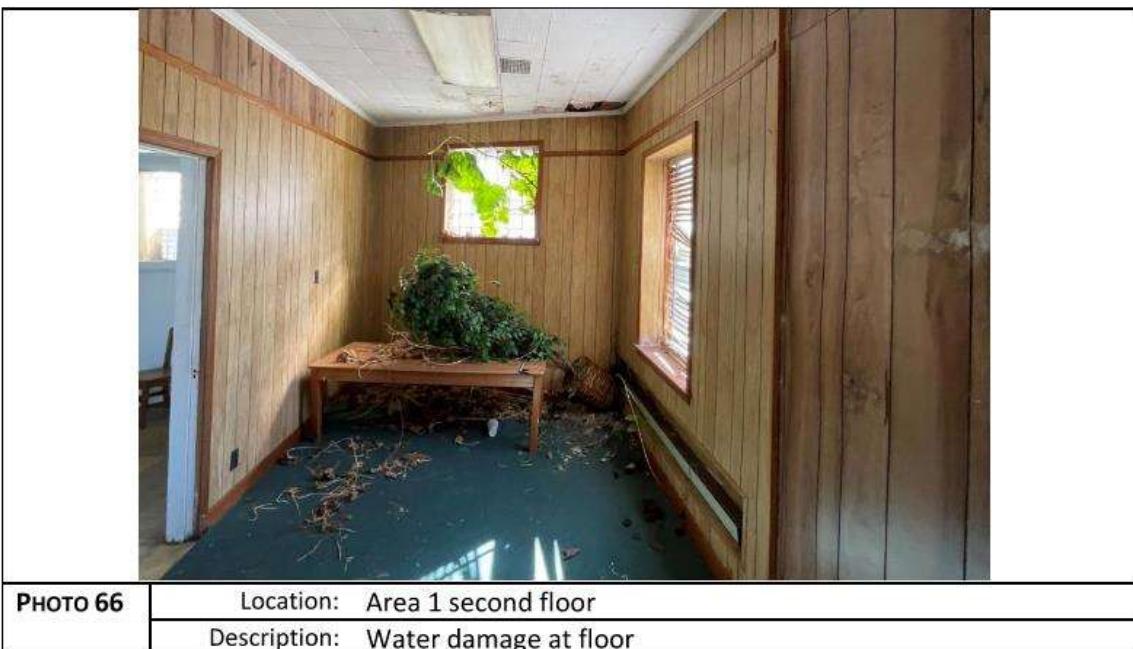
PHOTO 66	Location: Area 1 second floor
	Description: Water damage at floor

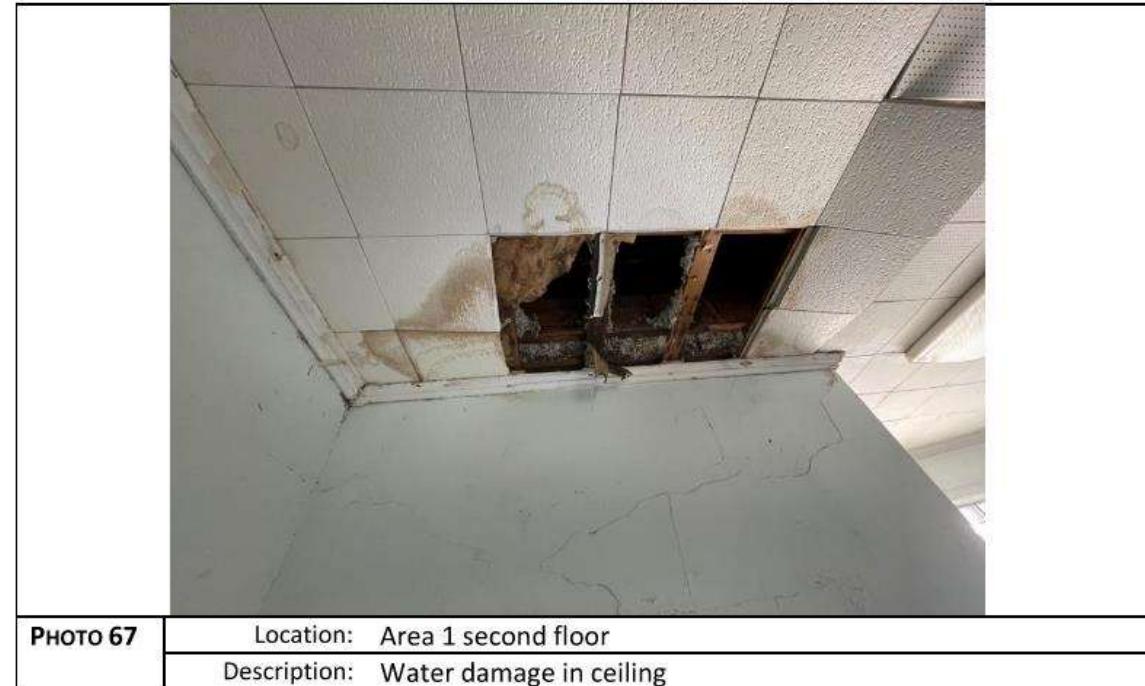
PHOTO 67	Location: Area 1 second floor
	Description: Water damage in ceiling

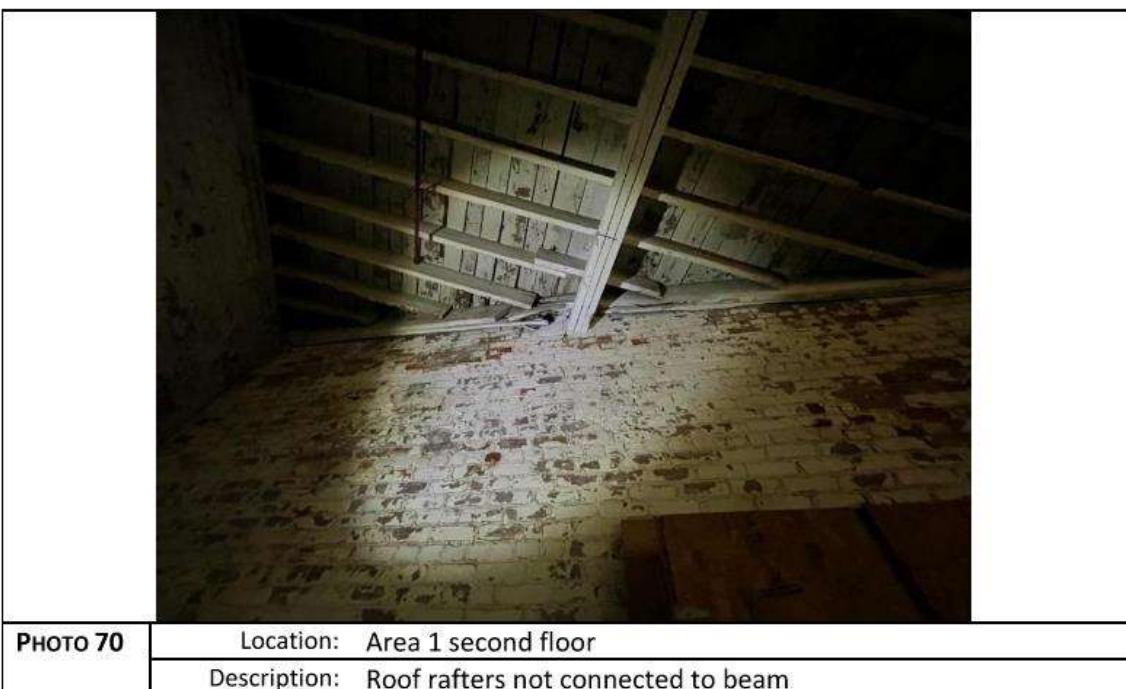
PHOTO 70 Location: Area 1 second floor
Description: Roof rafters not connected to beam

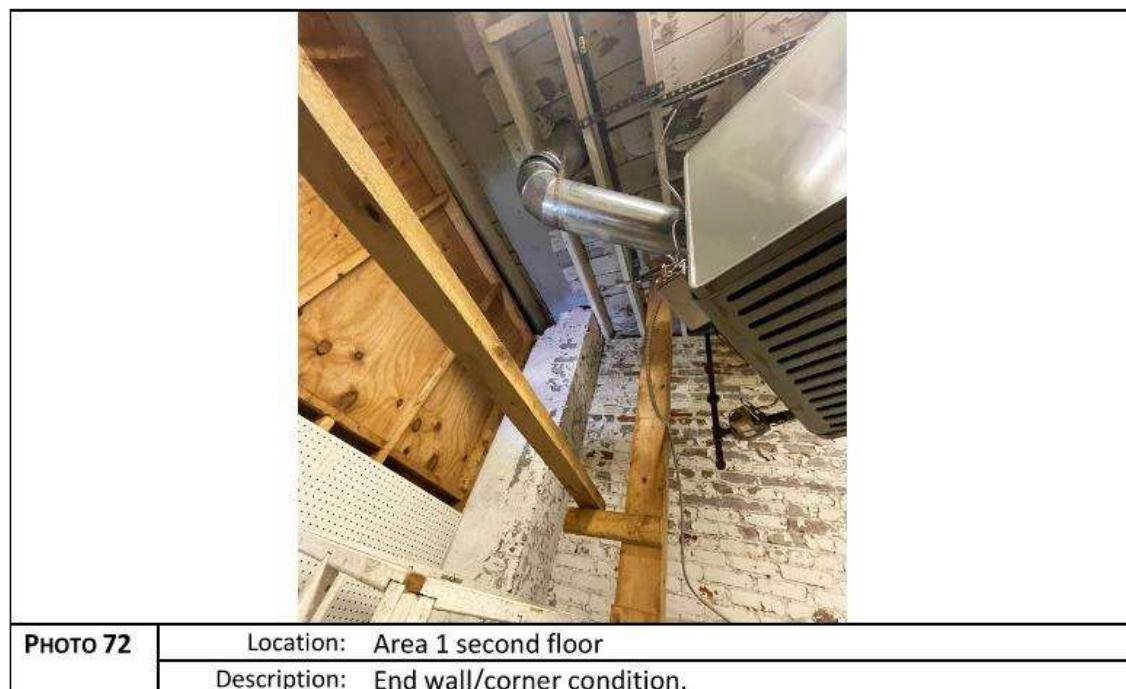
PHOTO 72 Location: Area 1 second floor
Description: End wall/corner condition.

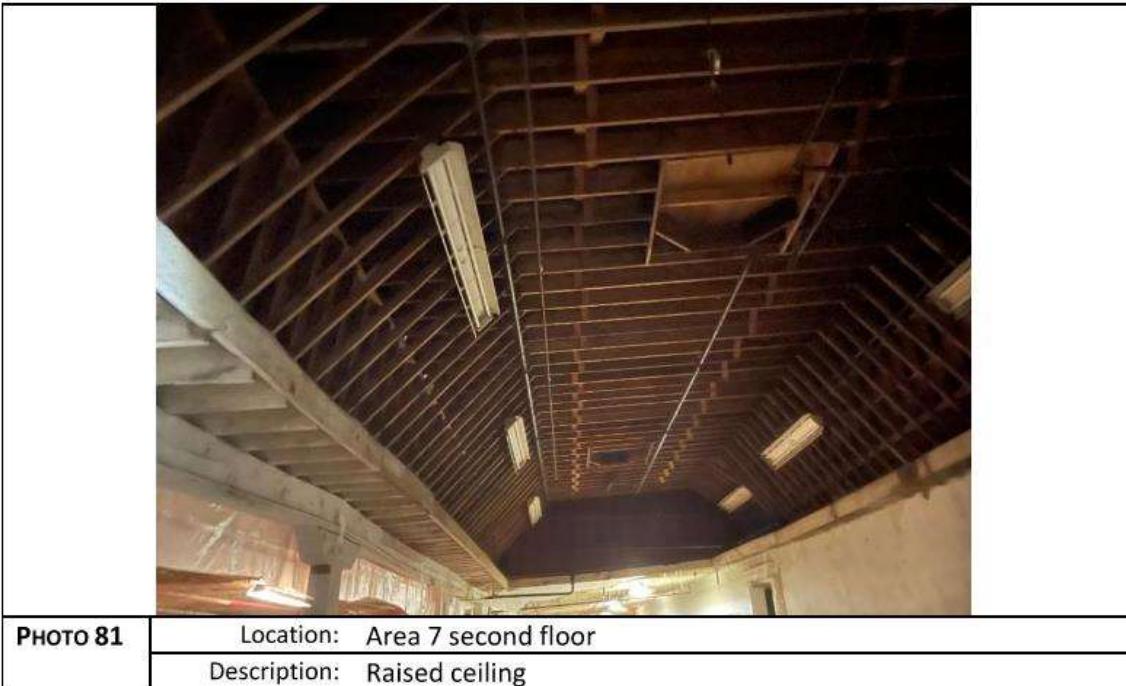
PHOTO 81 Location: Area 7 second floor
Description: Raised ceiling

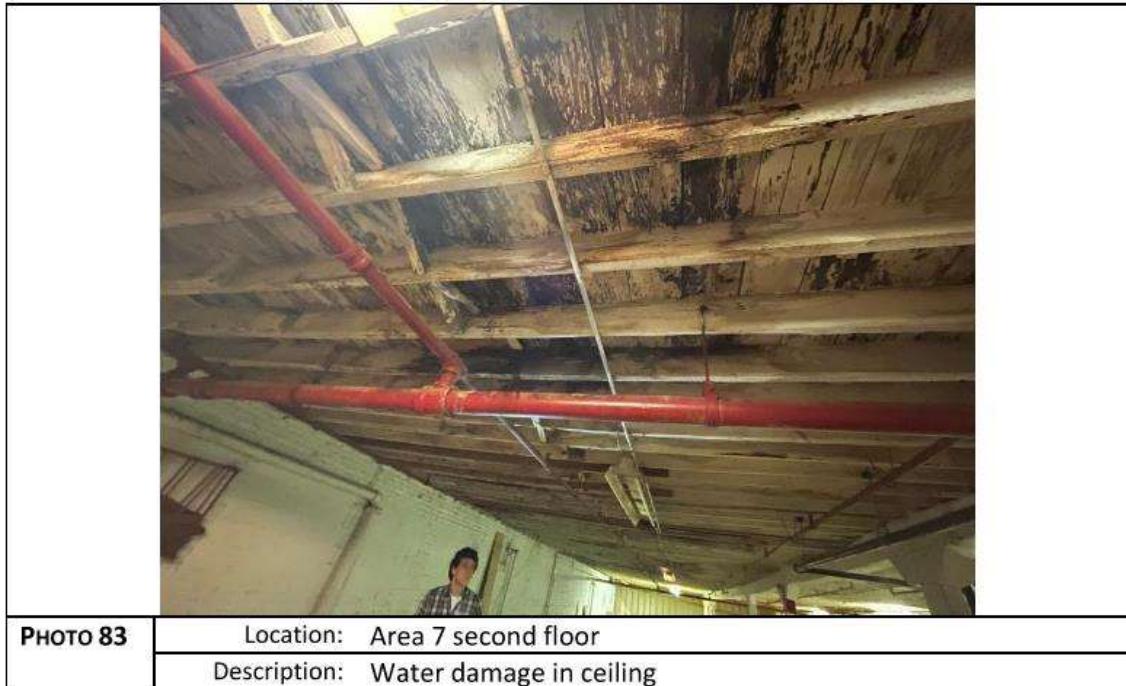
PHOTO 83 Location: Area 7 second floor
Description: Water damage in ceiling

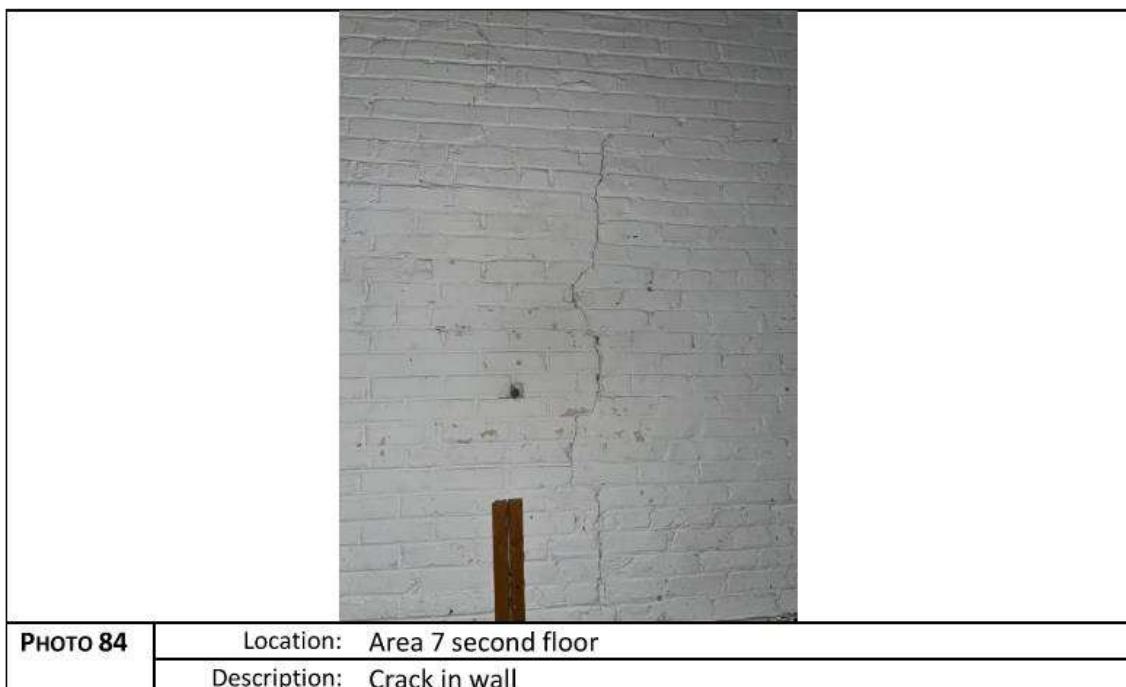
PHOTO 84 Location: Area 7 second floor
Description: Crack in wall

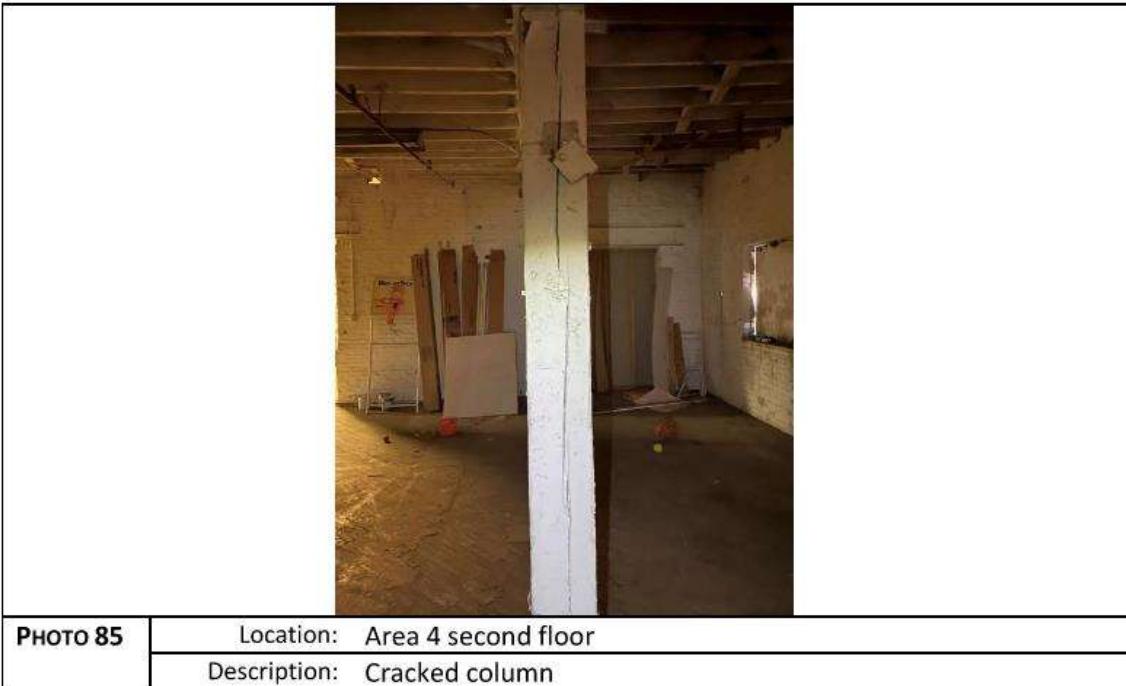
PHOTO 85 Location: Area 4 second floor
Description: Cracked column

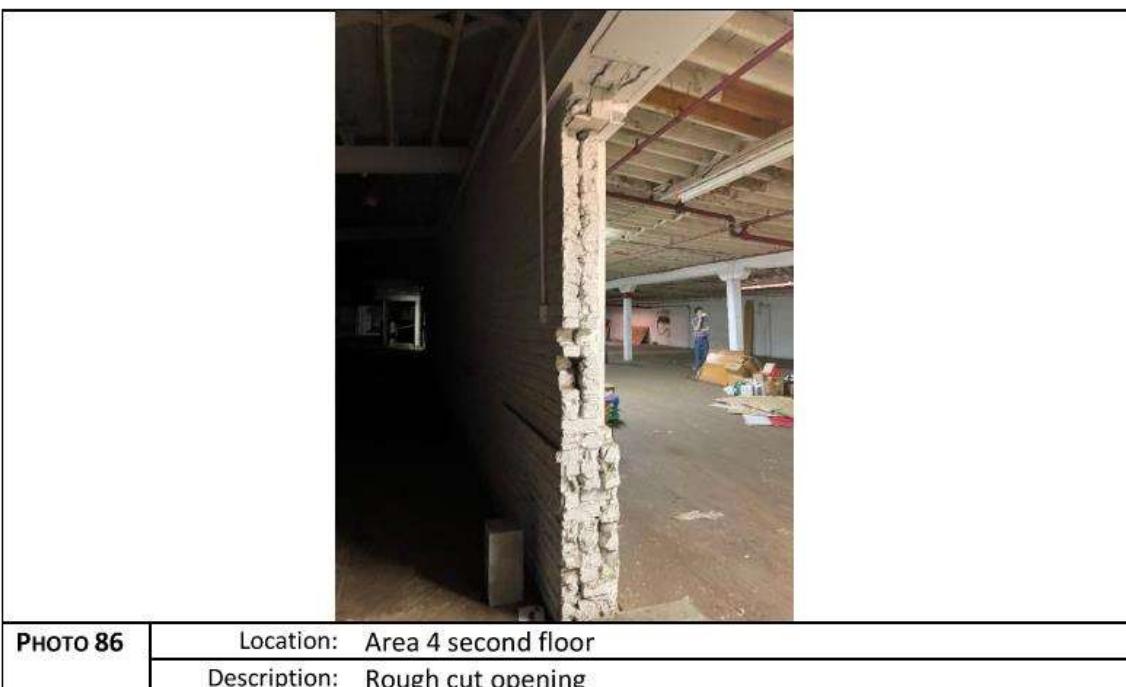
PHOTO 86 Location: Area 4 second floor
Description: Rough cut opening

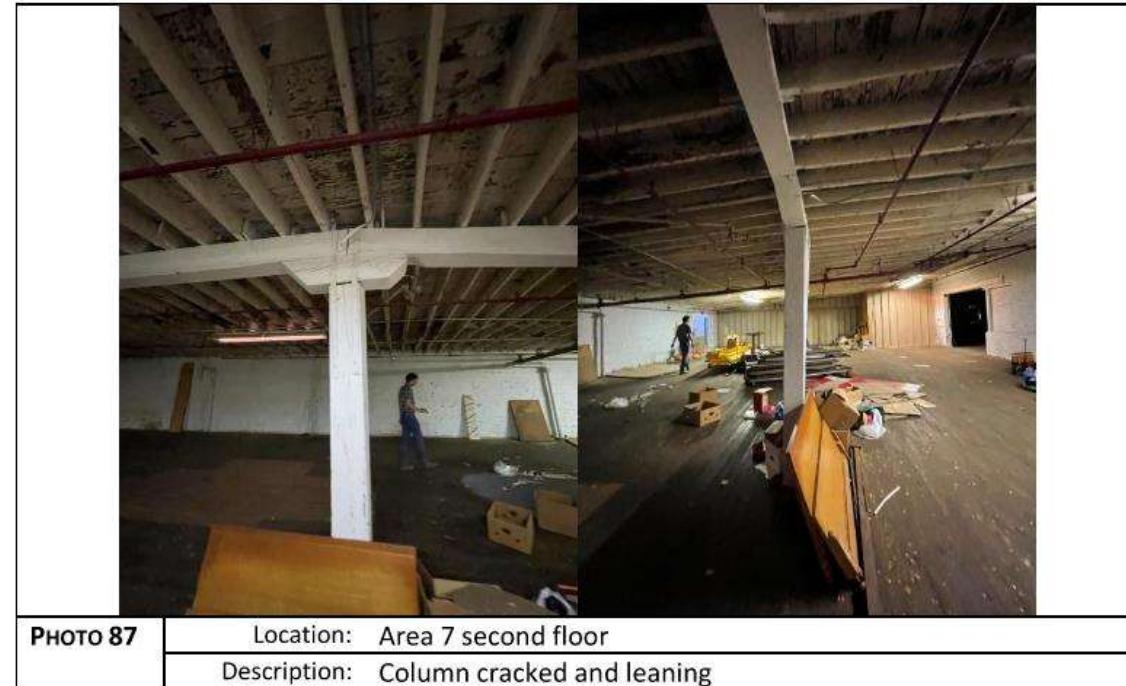
PHOTO 87 Location: Area 7 second floor
Description: Column cracked and leaning

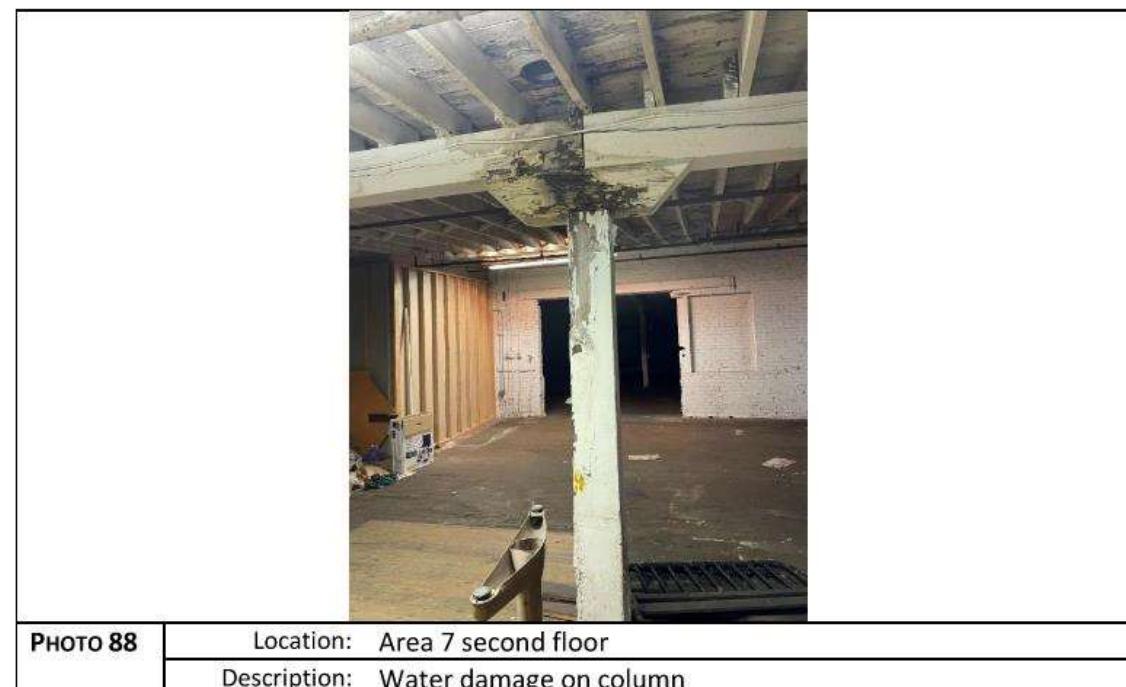
PHOTO 88 Location: Area 7 second floor
Description: Water damage on column
