This Study documents our observations of existing conditions and identifies several options for redevelopment of the former American Furniture Plant #10; an operational pro forma of the City's preferred option is included.

Existing Conditions – Site

Existing Conditions – Building

Field Observations & Recommendations

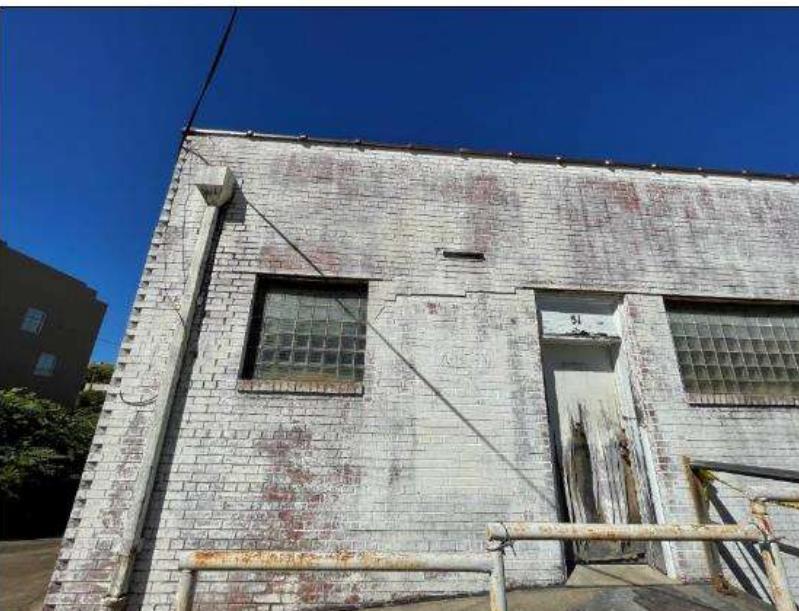
48. The masonry wall near the east man-doors exhibits cracking. The wall above and below the crack is slightly out of plane. (Photo 2)
49. Brick and mortar along the edge of sidewalk are washed with some gaps. (Photos 3 and 4)
50. The north wall exhibits cracking. There is also a void under the slab at the one door way. (Photos 5 and 6) *Significant cracks should be stitched and repointed.*

PHOTO 2 Location: Area 1 exterior
Description: Cracking, slightly out of plane wall

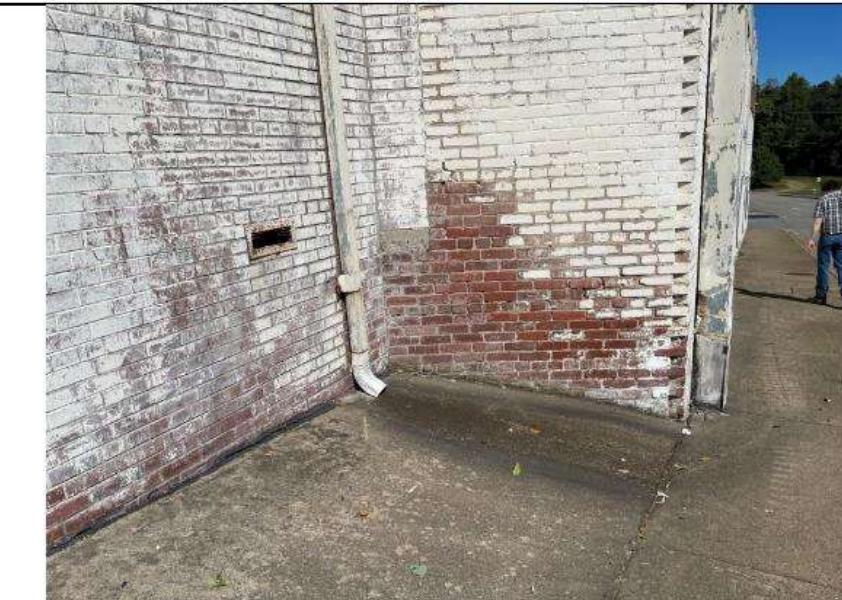
PHOTO 3 Location: Area 1 exterior
Description: General condition. Minor wash around downspout and sidewalk

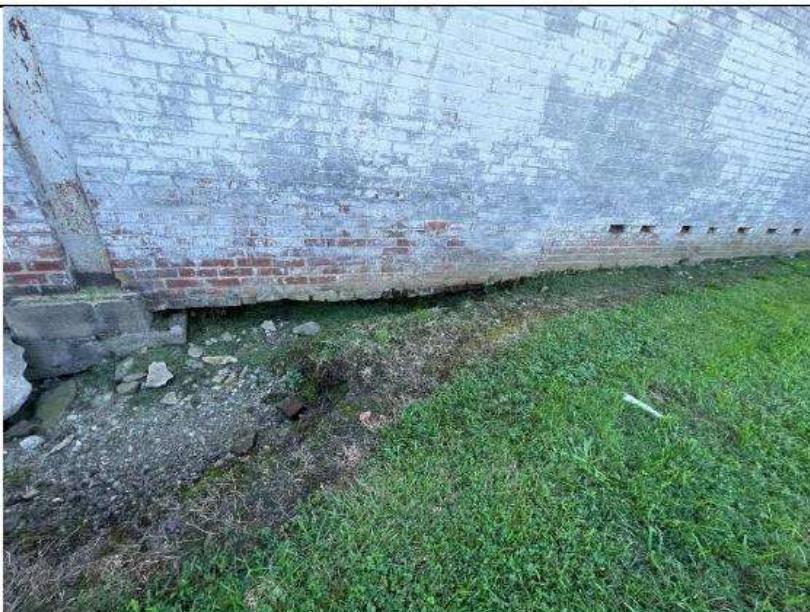
51. The north wall brick and foundation in this area are undermined. (Photo 9) It is also questionable if the underdrain/ storm drain is functioning adequately. (Photo 8) *Alterations to the structure should include a storm drain study/redesign.*

PHOTO 9	Location: Area 2 exterior
	Description: Undermining

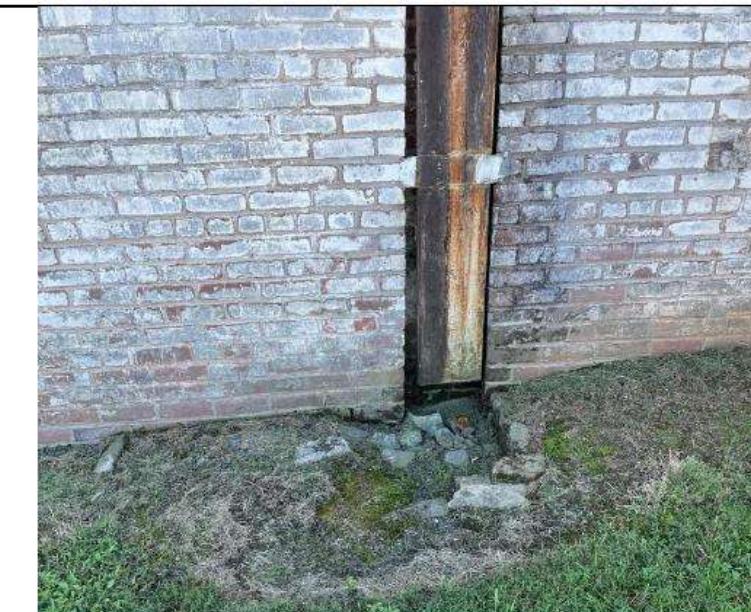
PHOTO 11	Location: Area 4 exterior
	Description: Drain exhibiting damage. Drainage to underdrain clogged.

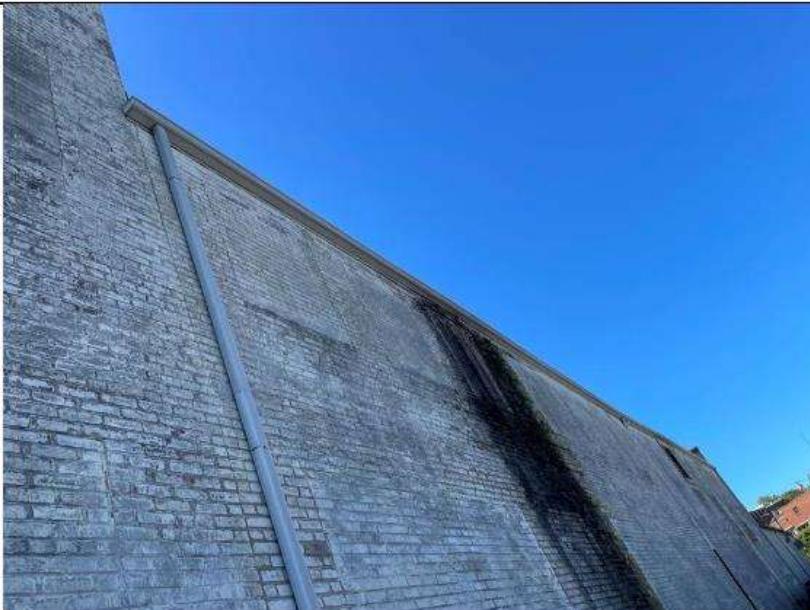
52. The north wall exhibits significant water staining. (Photo 10) *It is unclear if this is active or from damage before drain and gutter work was performed. A further investigation to prevent future water exposure should be performed and planned in any alterations.*
53. There are concerns with the downspout drainage in this area. (Photo 11)
54. There are voids in the mortar above the dock door, and the brick exhibits water staining and wash. (Photos 12 and 13) *This area should be repointed.*
55. There is stair step cracking northwest corner of the exterior wall.

PHOTO 10	Location: Area 4 exterior
	Description: Significant staining on wall.

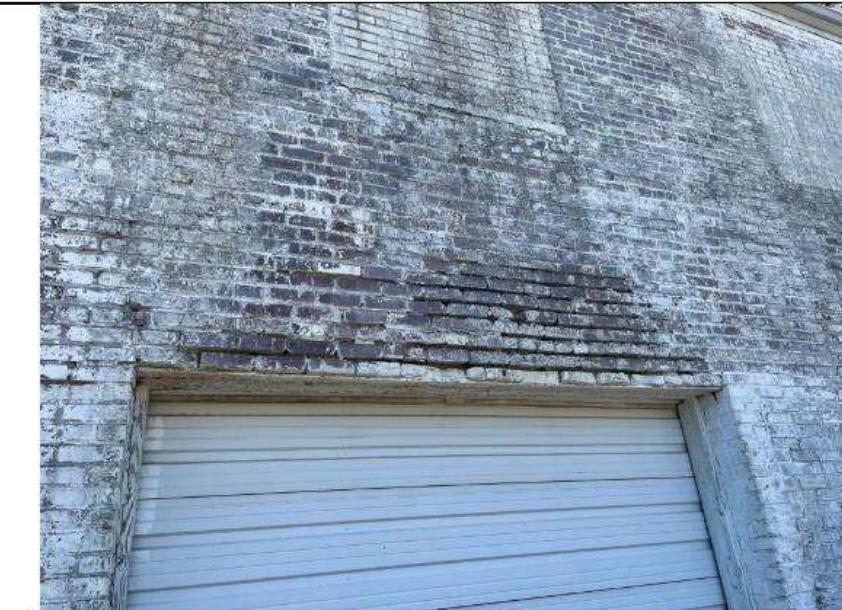
PHOTO 12	Location: Area 4 exterior
	Description: Voids in mortar and water staining

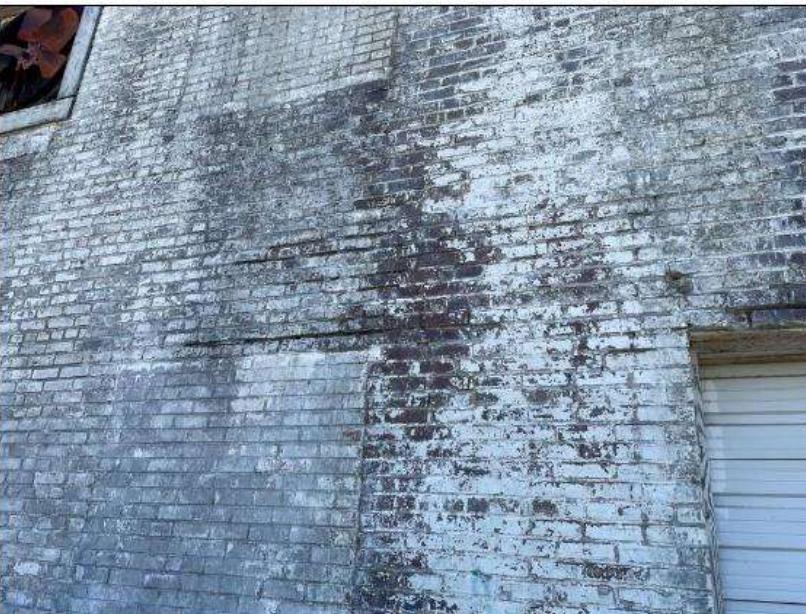
PHOTO 13	Location: Area 4 exterior
	Description: Voids in mortar and water staining

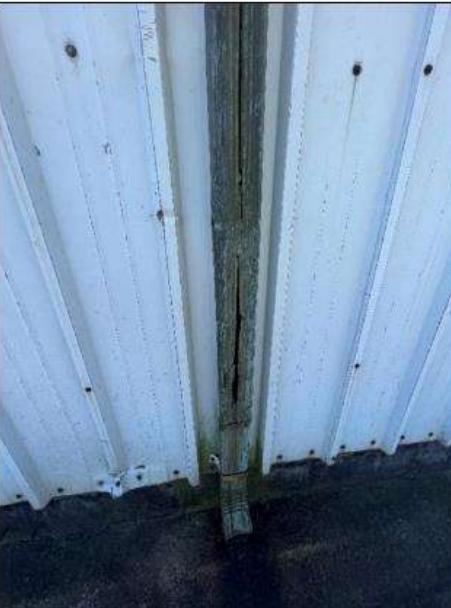
PHOTO 14	Location: Area 5 exterior
	Description: Split downspout

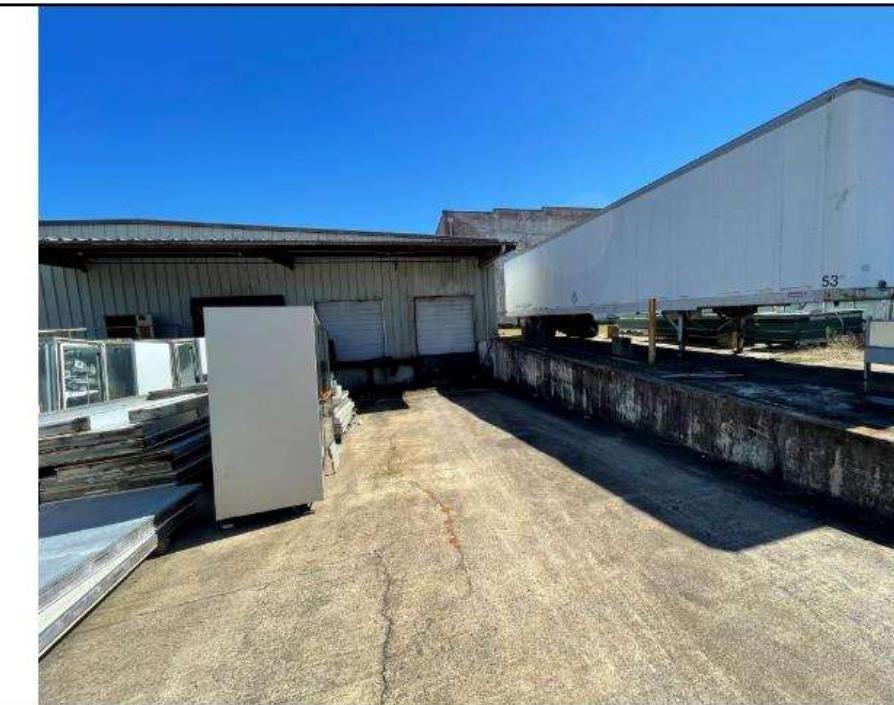
56. There is no railing at the loading dock. The concrete wall has a slight lean. (Photo 16) *We recommend adding a guardrail if the loading dock is to remain. Drainage and around the wall should also be improved.*
57. Siding on this wall damaged. (Photo 18) *Siding will most likely be addressed in alterations; however, we recommend a more immediate patching of areas that have holes.*

PHOTO 16	Location: Area 5 exterior
	Description: No railing on concrete wall. Wall has slight lean.

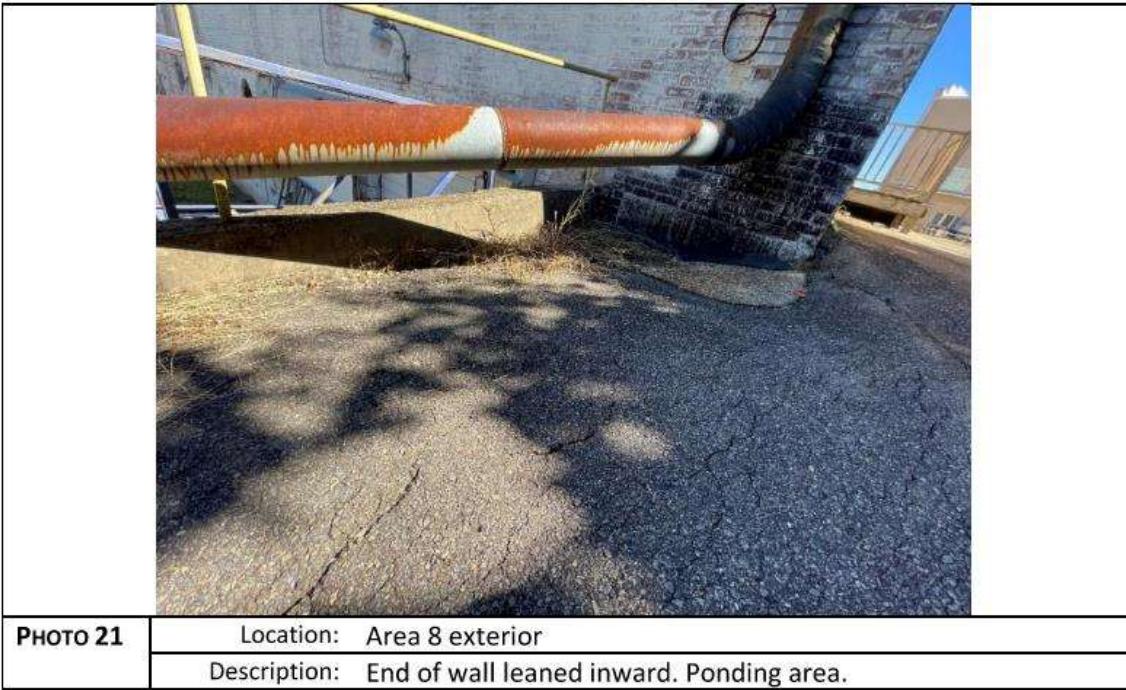
61. The site wall at the southwest corner exhibits minor leaning and also has a disconnected water drain line from the roof that is causing a hole at the end (Photo 21 and 20). We recommend reworking site drainage in this area.

PHOTO 21 Location: Area 8 exterior
Description: End of wall leaned inward. Ponding area.

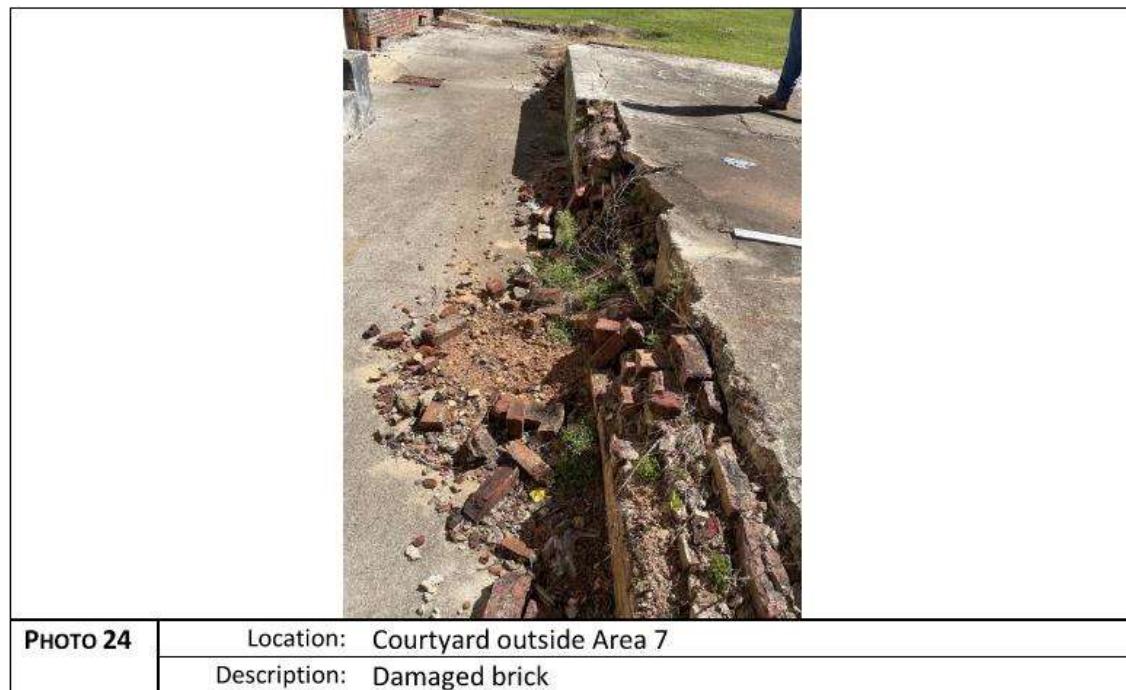
PHOTO 24 Location: Courtyard outside Area 7
Description: Damaged brick

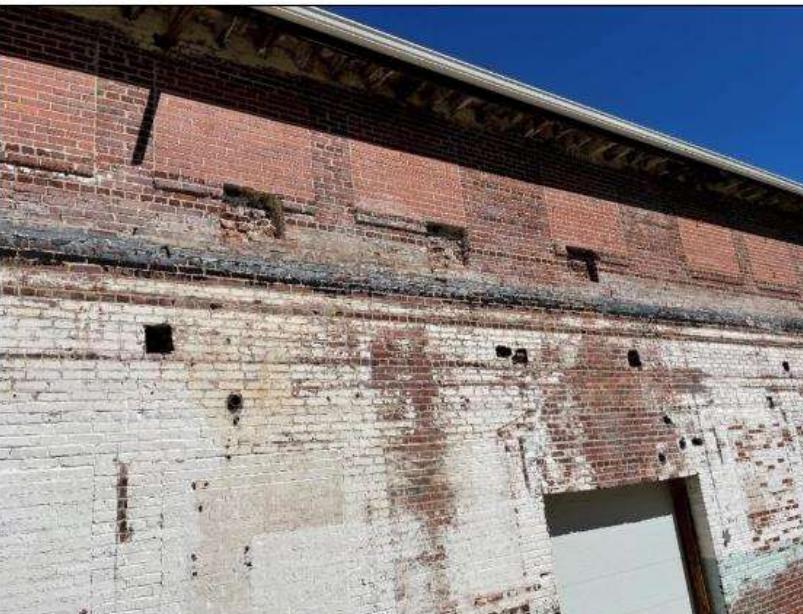
58. There are a few locations along the south wall with minor cracks and holes. (Photos 25 and 26) *We recommend filling holes and repointing/stitching cracks where needed.*

PHOTO 25 Location: Area 7 exterior
Description: Cracking, holes in brick wall

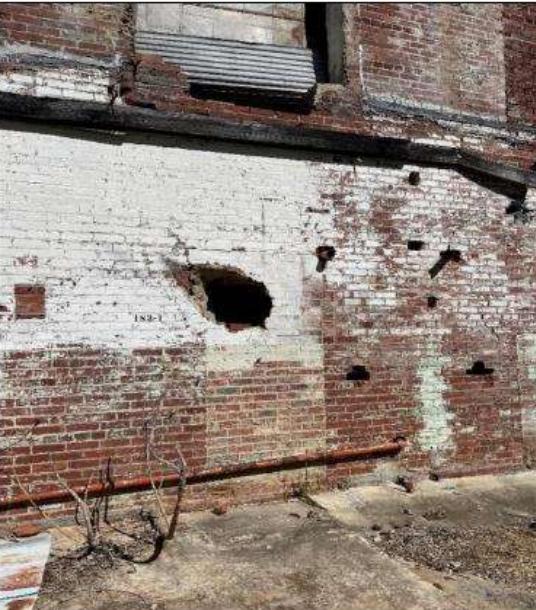
PHOTO 26 Location: Area 7 exterior
Description: Cracking, holes in brick wall

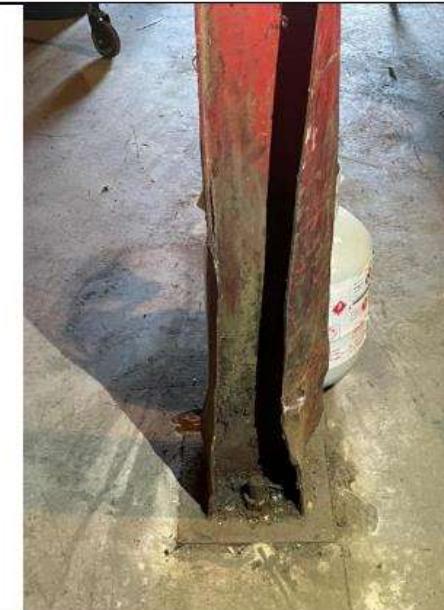
15. There is a column (located in the note log) with flange deformation, likely caused by an impact. (Photo 28) *We recommend replacing a portion of the column with a new W-shape of greater or equal size; or cladding the bottom portion of the column where the flange is bent with c-shape members to provide strength.*

PHOTO 28 Location: Area 5 first floor
Description: Damaged column

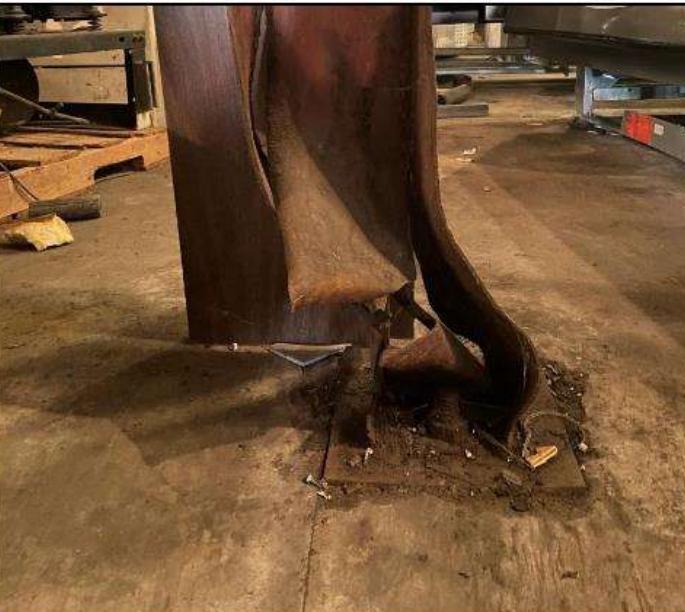
14. There is a column with almost a completely sheared and deformed base. (Photo 29) This is likely the result of an impact. The column is incapable of properly transferring load to the base. *We recommend that this column be replaced with a W-shape of greater than or equal size.*

PHOTO 29 Location: Area 5 first floor
Description: Damaged column

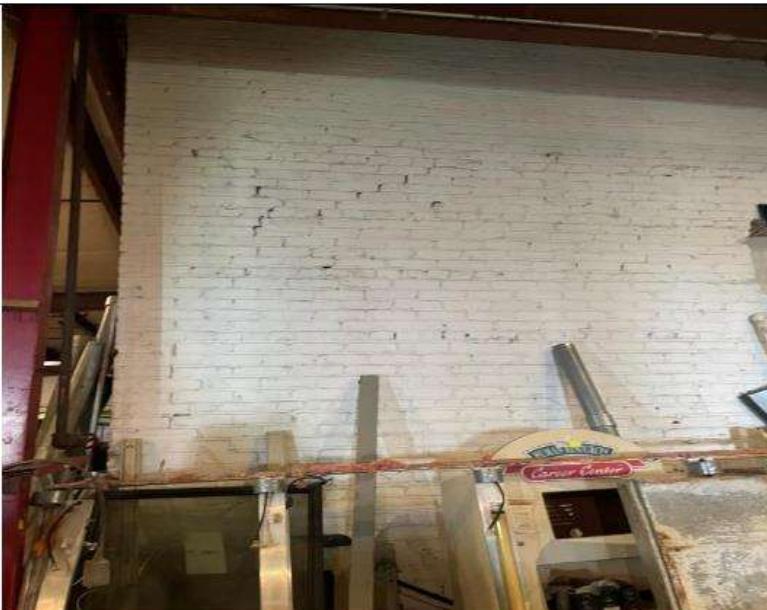
16. The masonry wall between Area 5 and 6 exhibits cracking in multiple locations. (Photos 30 and 31) The majority of the cracks are hairline. *We recommend repointing cracks and providing stiches for significant cracks.*

PHOTO 30 Location: Area 5 first floor
Description: Cracks along wall

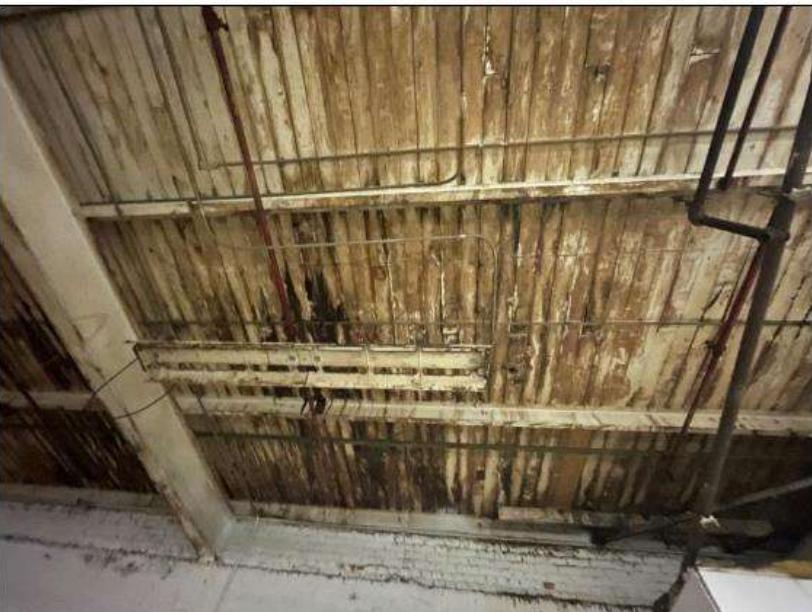
25. The west, exterior wall exhibits minor cracking and small holes from previous conduit and ductwork.
26. Numerous columns in this area exhibit minor damage at or near the bases. (Photo 38)
27. Significant water staining of the underside of deck along the south wall. (Photos 35, 36, and 37). At the location of Photo 37, floor damage and sagging were noted above. Other areas of the floor were soft when walked on upstairs; however, not all of the floor was accessible due to furniture and other coverings. *Once the area is removed of all items and*

PHOTO 37	Location: Area 8 first floor
	Description: Water staining on framing above

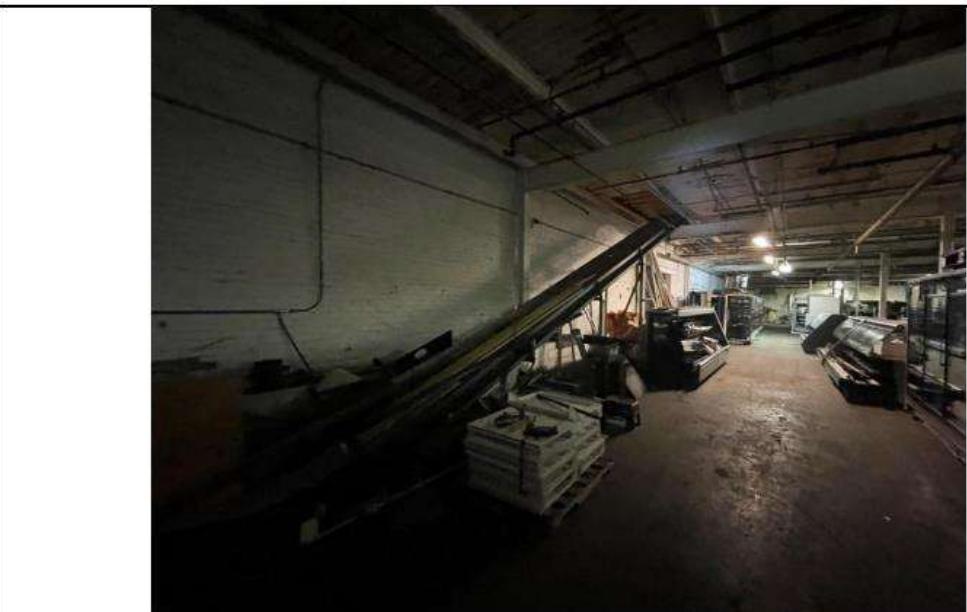
PHOTO 39	Location: Area 8 first floor
	Description: Overall view

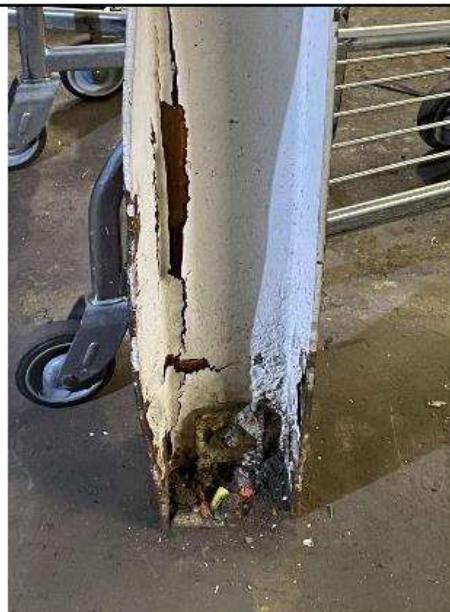
PHOTO 38	Location: Area 8 first floor
	Description: Typical damage to base of column.

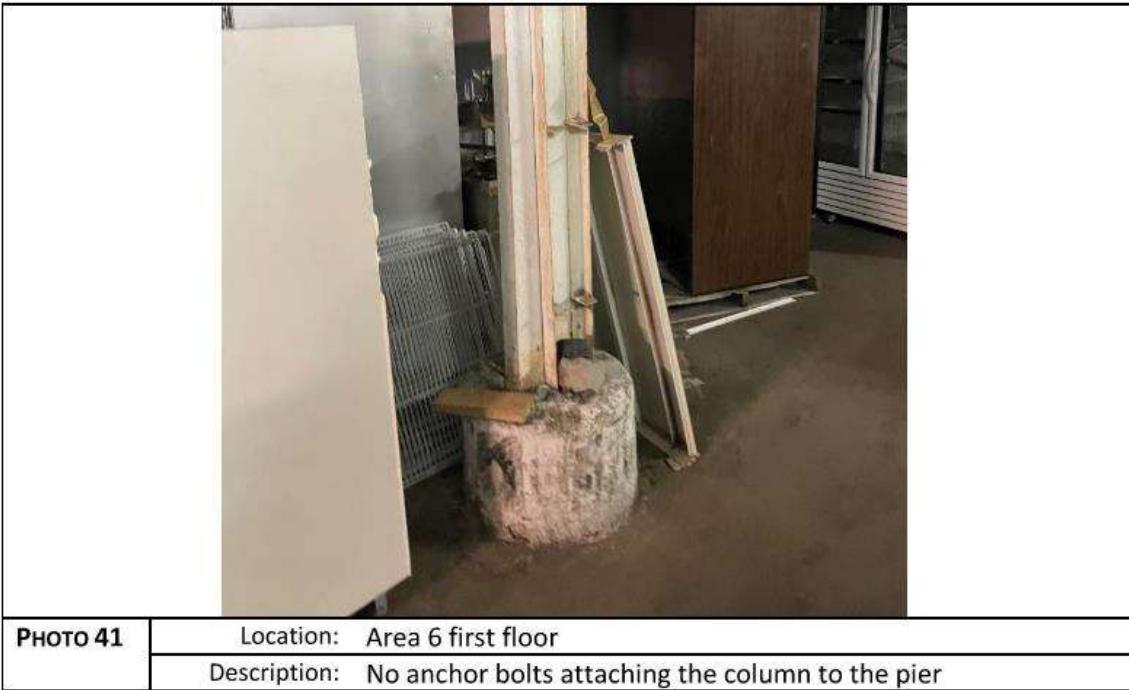
17. The east column of this area had a built-up member with no anchor bolts in the base plate. (Photo 41) *We recommend installing post-installed anchors in holes of the base plate.*

PHOTO 41 Location: Area 6 first floor
Description: No anchor bolts attaching the column to the pier

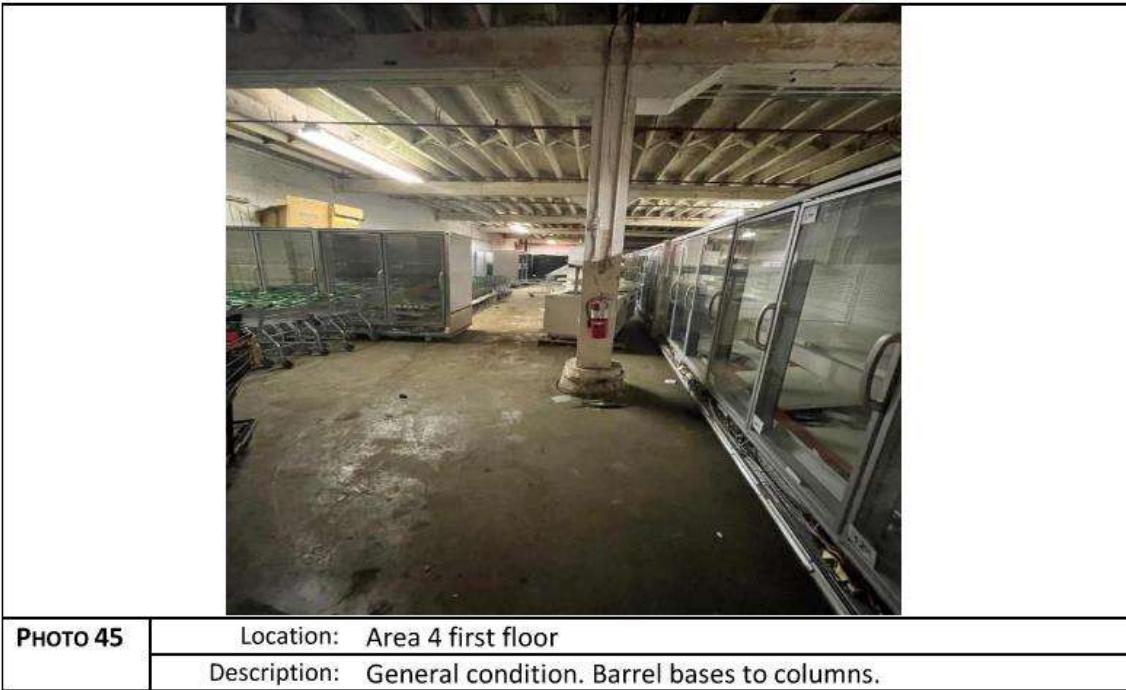
PHOTO 45 Location: Area 4 first floor
Description: General condition. Barrel bases to columns.

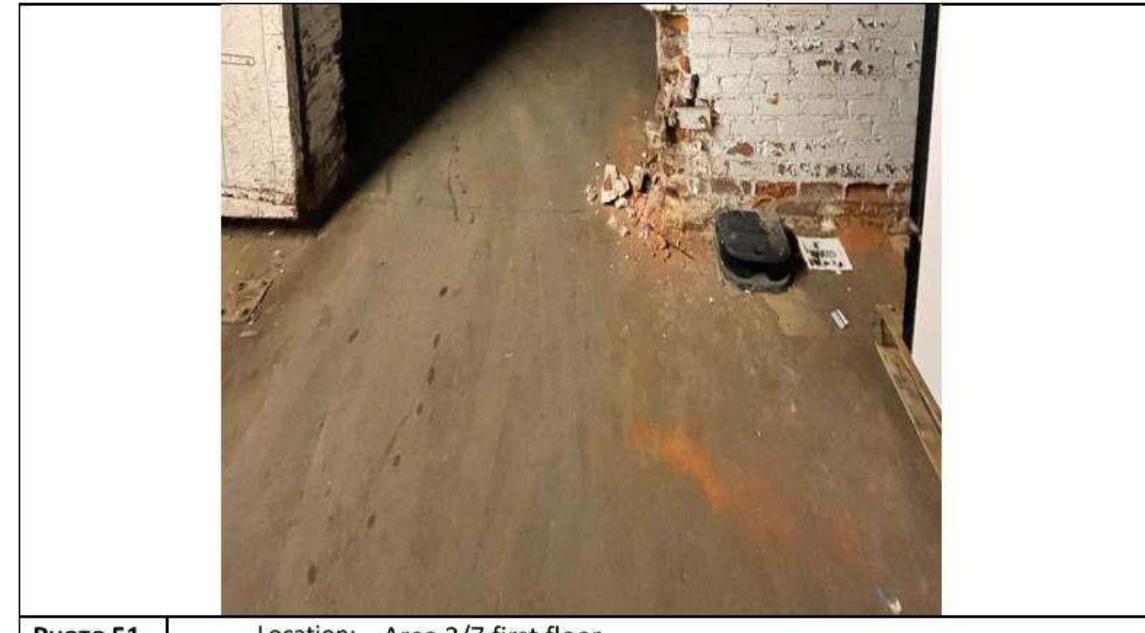
18. Soft brick was noted at the bottom of the wall at the opening between Area 7 and Area 2. (Photo 51). There is also damage to the base of the door jamb. *Repair damaged area of brick. Replace brick that has popped beyond 1/4" deep.*

PHOTO 51	Location: Area 2/7 first floor
	Description: Soft brick at base of opening

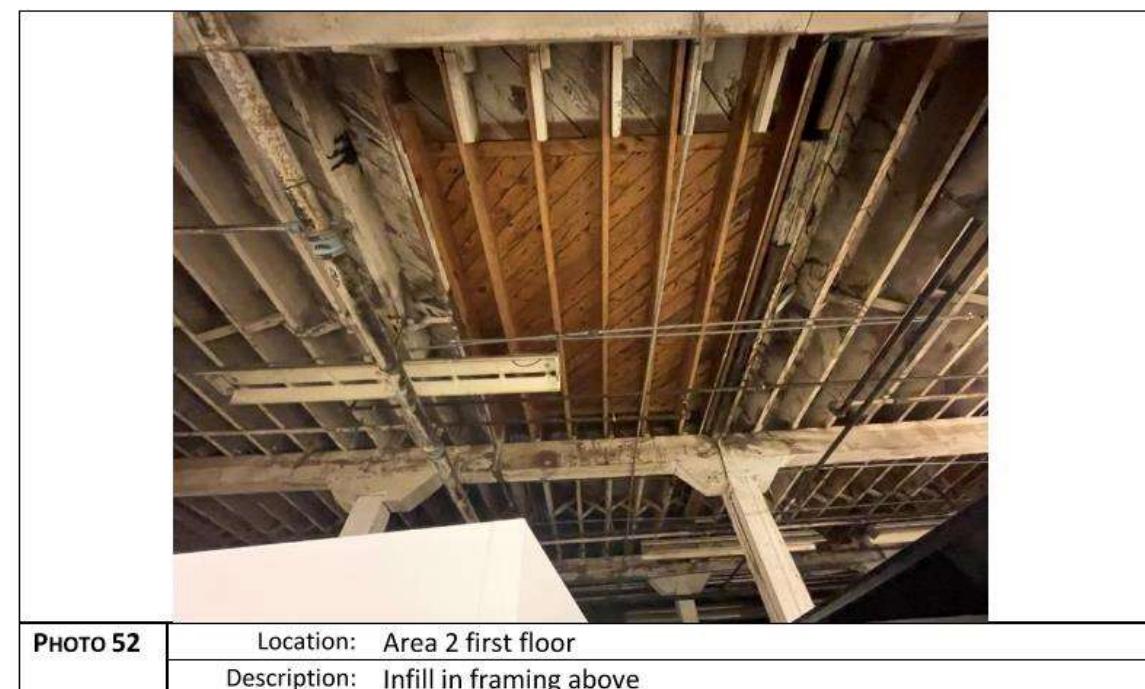
PHOTO 52	Location: Area 2 first floor
	Description: Infill in framing above

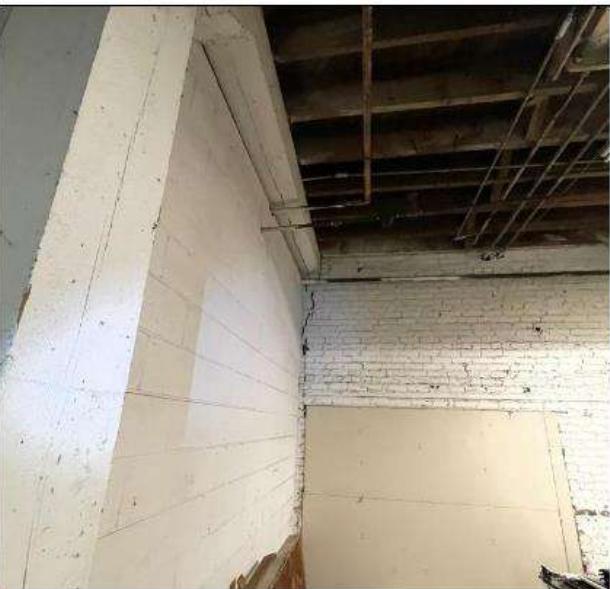
4. There is an opening in the northwest section of this area leading to Area 2 that exhibits significant cracking on both sides of the wall, likely the result of a large impact. Damages included staircase cracking above the opening and loss of masonry at the bearing points. (Photos 53, 54, 59, and 60) *It is recommended that the lintel and masonry be reconstructed, with cracks stitched together or bricks retoothing.*

PHOTO 53	Location: Area 2 first floor
	Description: Significant damage to masonry at opening

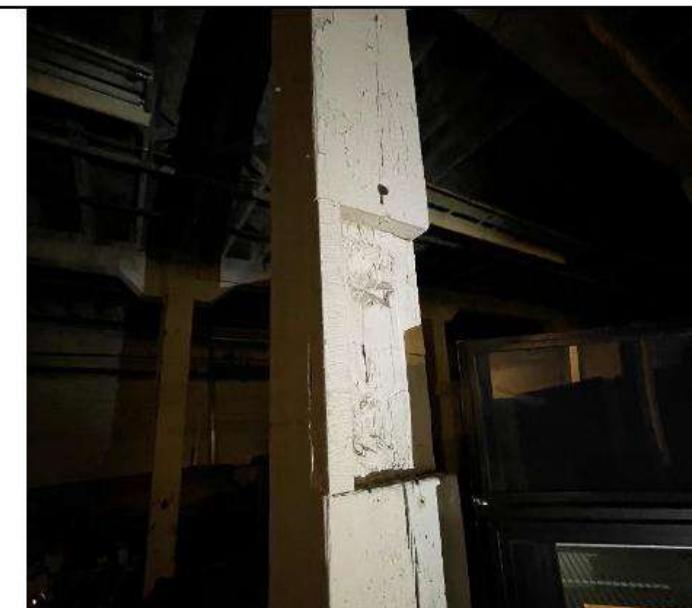
PHOTO 56	Location: Area 2 first floor
	Description: Crack in column and notch.

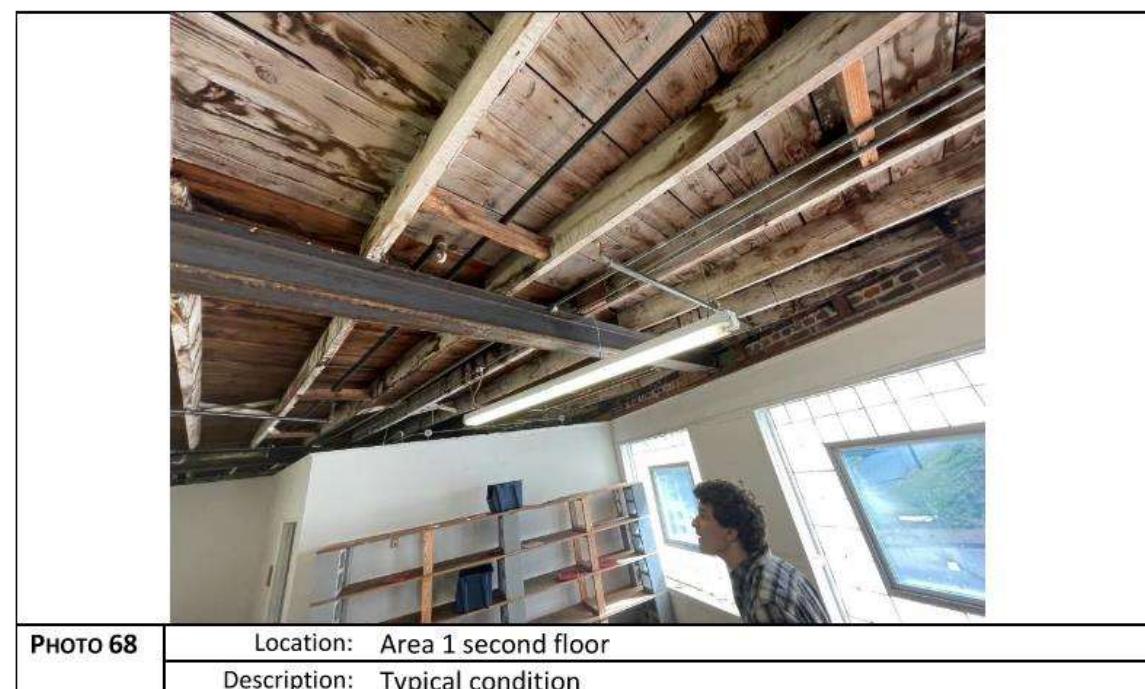
PHOTO 68	Location: Area 1 second floor
	Description: Typical condition

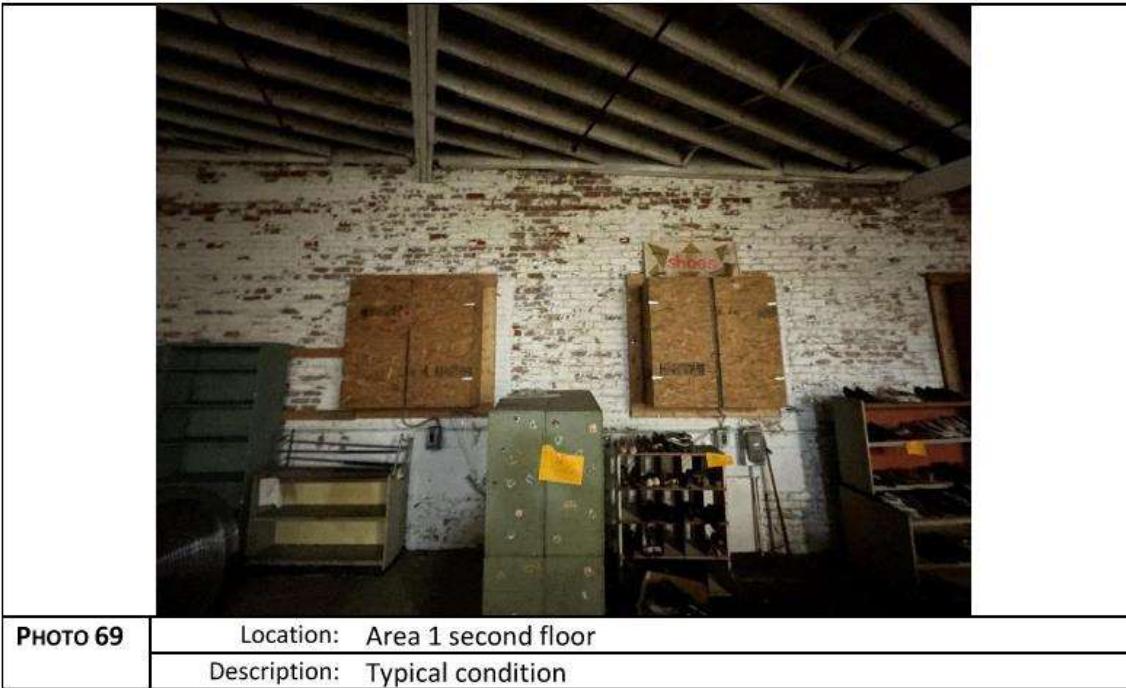
PHOTO 69 Location: Area 1 second floor
Description: Typical condition

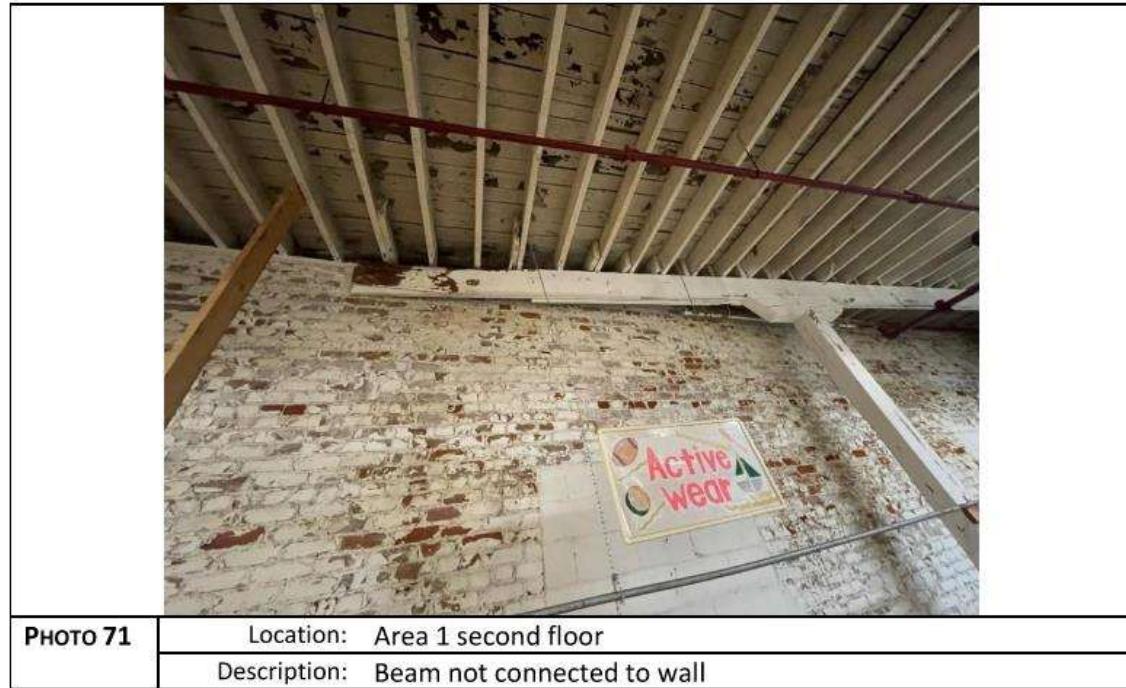
32. There is a split in the middle-north column that runs the full height. *We recommend stabilizing or replacement.*
33. The northern most roof beam stops at the face of the wall with no connection to the wall and has a larger cantilever. (Photo 71) *We recommend providing a positive attachment to the wall.*

PHOTO 71 Location: Area 1 second floor
Description: Beam not connected to wall

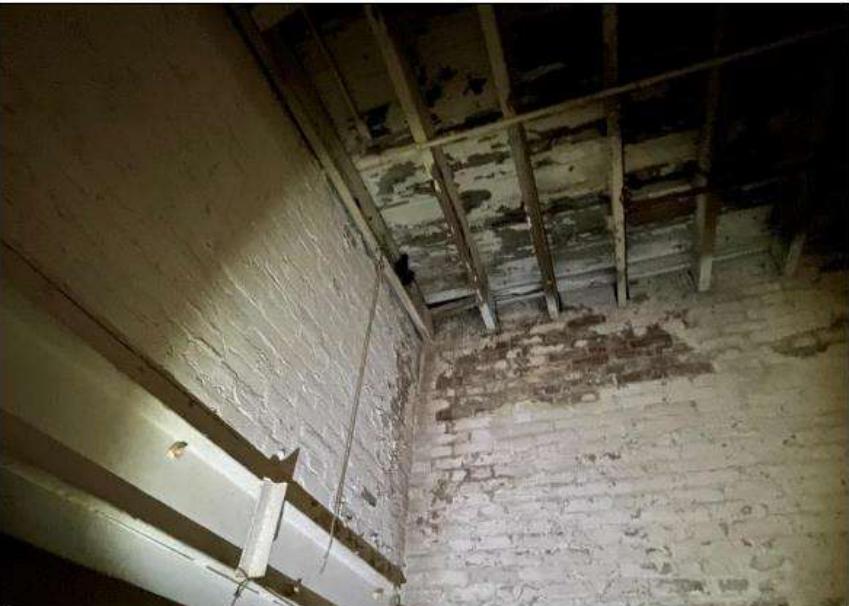
PHOTO 77	Location: Area 2 second floor
	Description: Water damage/staining roof and wall.

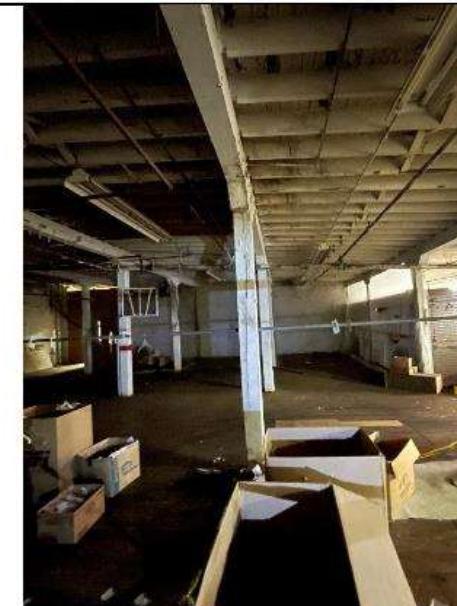
PHOTO 79	Location: Area 2 second floor
	Description: Bowed column

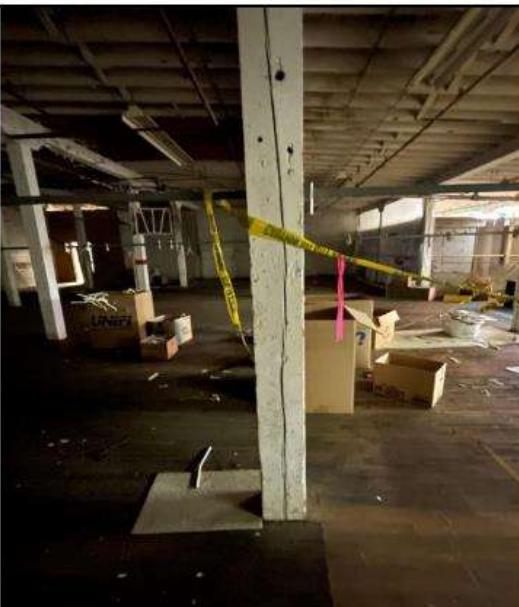
39. There are two columns near the middle of the area that exhibit cracking along the full height. (Photo 78)

PHOTO 78	Location: Area 2 second floor
	Description: Crack in column

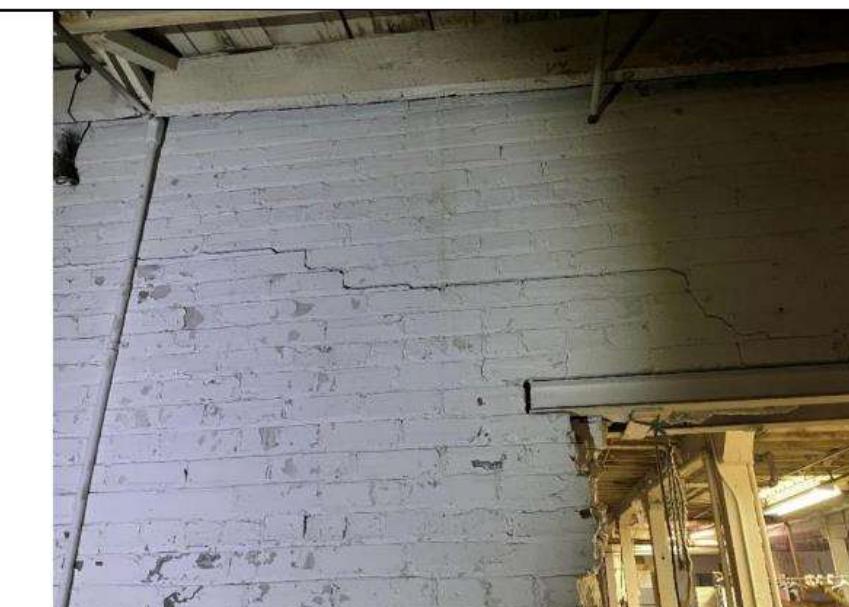
36. The west wall between Area 2 and 3 exhibits minor cracking. (Photo 74) *We recommend stitching and repointing cracks.*
37. The masonry walls around openings between Area 2 and 3 exhibit cracking. (Photos 75 and 80) *We recommend stitching and repointing cracks*
38. The roof framing exhibits water damage and deterioration in the northwest corner (Photo 77) and around an exhaust opening in the middle of the area (Photo 76). The exhaust opening also exhibits a joist that is cut and not properly headed off. *The area around roof penetrations should be reconstructed by sistering a new joist (if penetration is not needed anymore) or headed off properly and strengthening adjacent joists.*

PHOTO 80	Location: Area 2 second floor
	Description: Cracks in masonry

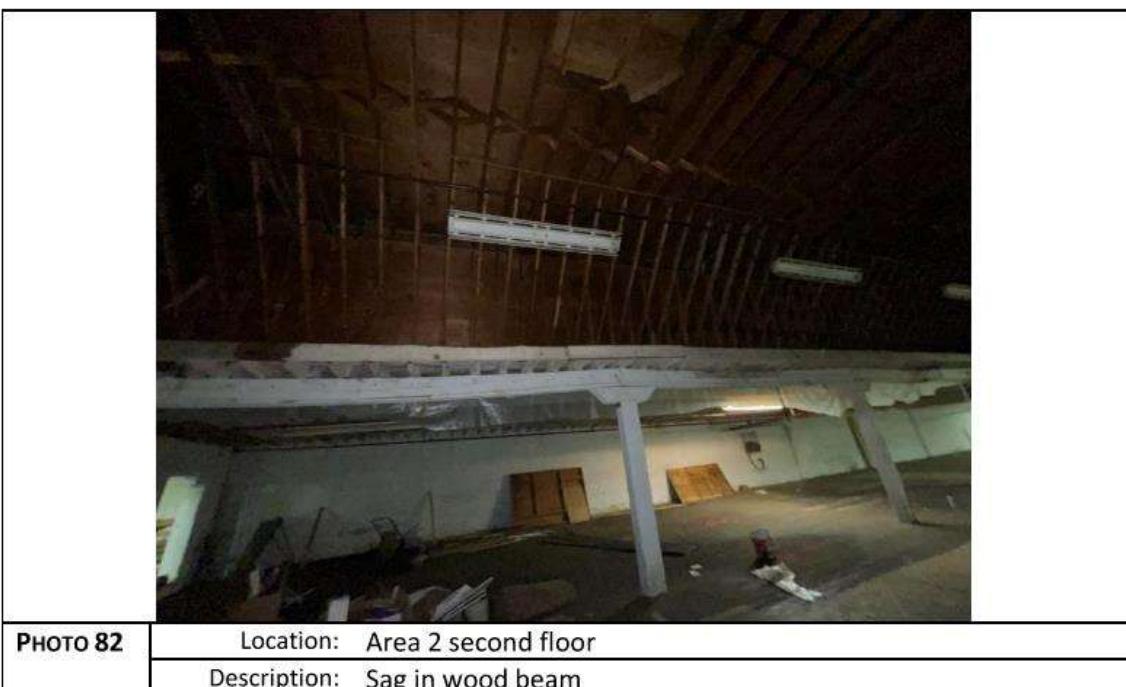
43. The center wood roof beams exhibit sag. (Photo 82) *These beams should be analyzed for existing and future loads and strengthened/stabilized.*
44. One of the center columns is leaning and has cracks. (Photo 87) Straps were previously added to the column for stabilization. The beams are also rotated in this area. *We recommend repairing the columns and surveying the below framing as well to determine full extents and reason of rotation and provide stabilization as required.*

PHOTO 82 Location: Area 2 second floor
Description: Sag in wood beam
